Blue smoke from exhaust after engine start

Topic number	LI09.40-P-055396
Version	2
Design group	09.40 Turbocharger
Date	02-12-2013
Validity	Vehicles with engine 271.8 EVO
Reason for change	Repair method changed. Installation of banjo bolt with integral valve
Reason for block

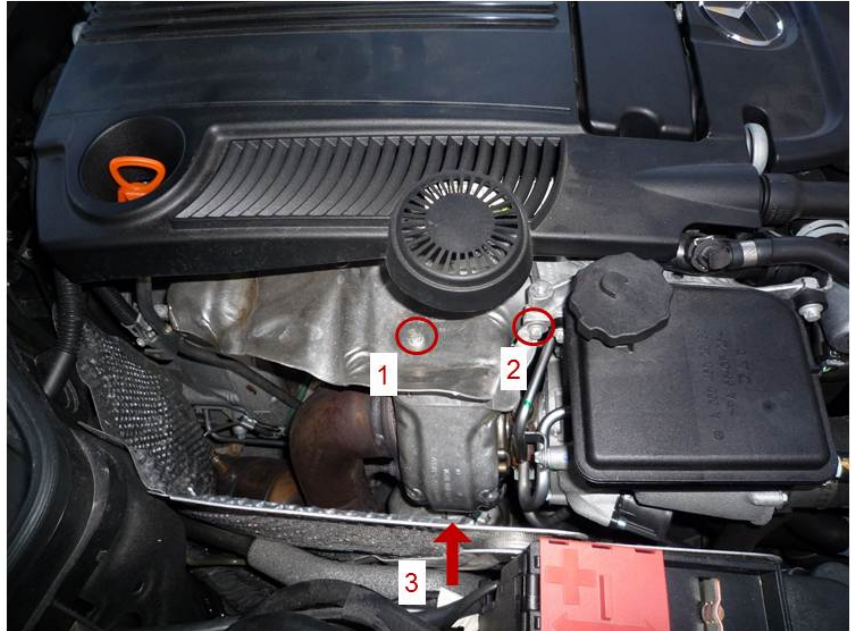
Screwings_turbocharger_
screening_plate.jpg:

Attachments	
File	Designation
Screwings_turbocharger_screening_plate.jpg	Shield - Installation location of bolts

- 1.) Detach small shield of turbocharger (see attachment for installation location of bolts).
- 2.) Remove oil feed line in accordance with WIS document AR09.40-P-6020-13EVO steps 1, 2 and 3
- 3.) Replace previous banjo bolt with banjo bolt with integral valve A0019972401. Observe revised tightening torque: 6 Nm + 90°
- 4.) Install in the reverse order

Note: The banjo bolt must be renewed each time it is removed.

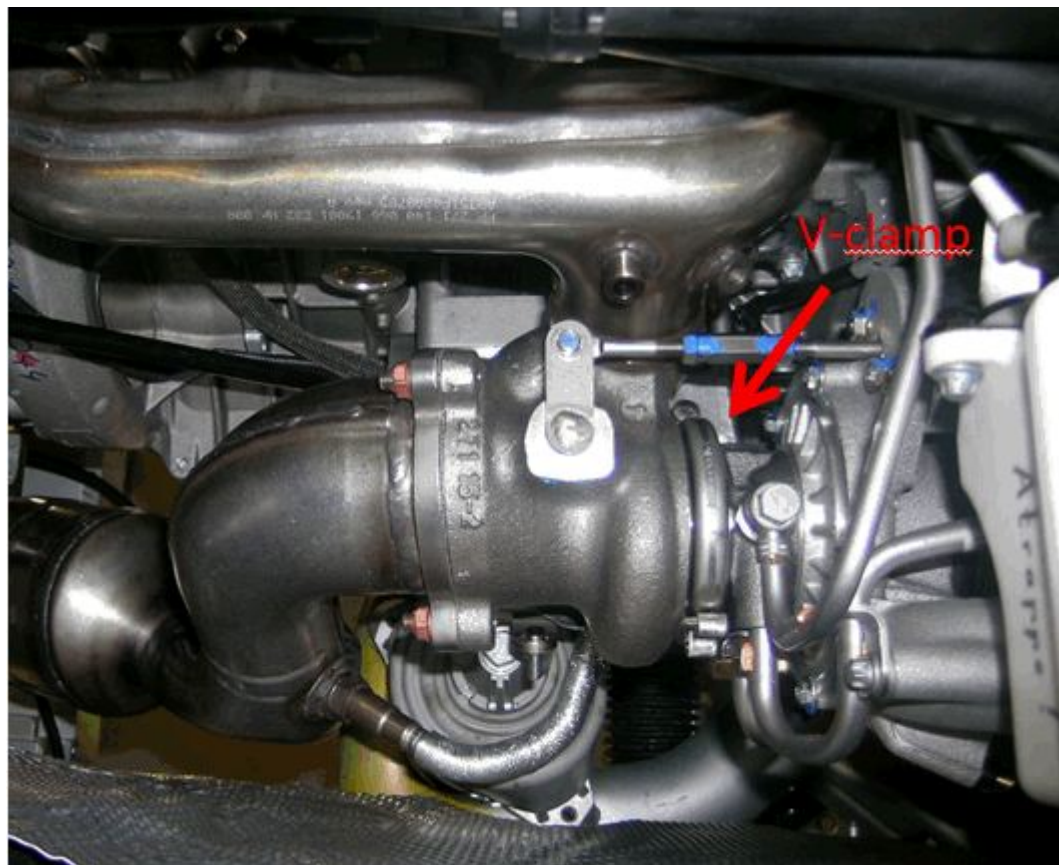
V-clamp.JPG:

When the engine is switched off, oil can continue to run out of the cylinder head via the oil feed line and can therefore seep into the bearing housing. In isolated cases capillary action can cause small residual oil quantities to travel to the turbine wheel and the V-clamp (refer to illustration in the attachments for location). After a long idle period this can lead to slight oil leakage at the V-clamp or to blue smoke problems when the cold engine is restarted.

Attachments	
File	Designation
V-clamp.JPG	V-clamp location

The turbocharger is technically OK and does not need to be replaced; it is sufficient to install a new banjo bolt with integral valve.
