Service Campaign Bulletin

Campaign No. 2011120006, February 2013

SUBJECT: **Model 451, Model Year 2011**
Update Electric Drive

This Service Campaign has been initiated because Daimler AG (DAG) has determined that the electric drive software may not meet current specifications. smart dealers will update the electric drive software at the next workshop visit.

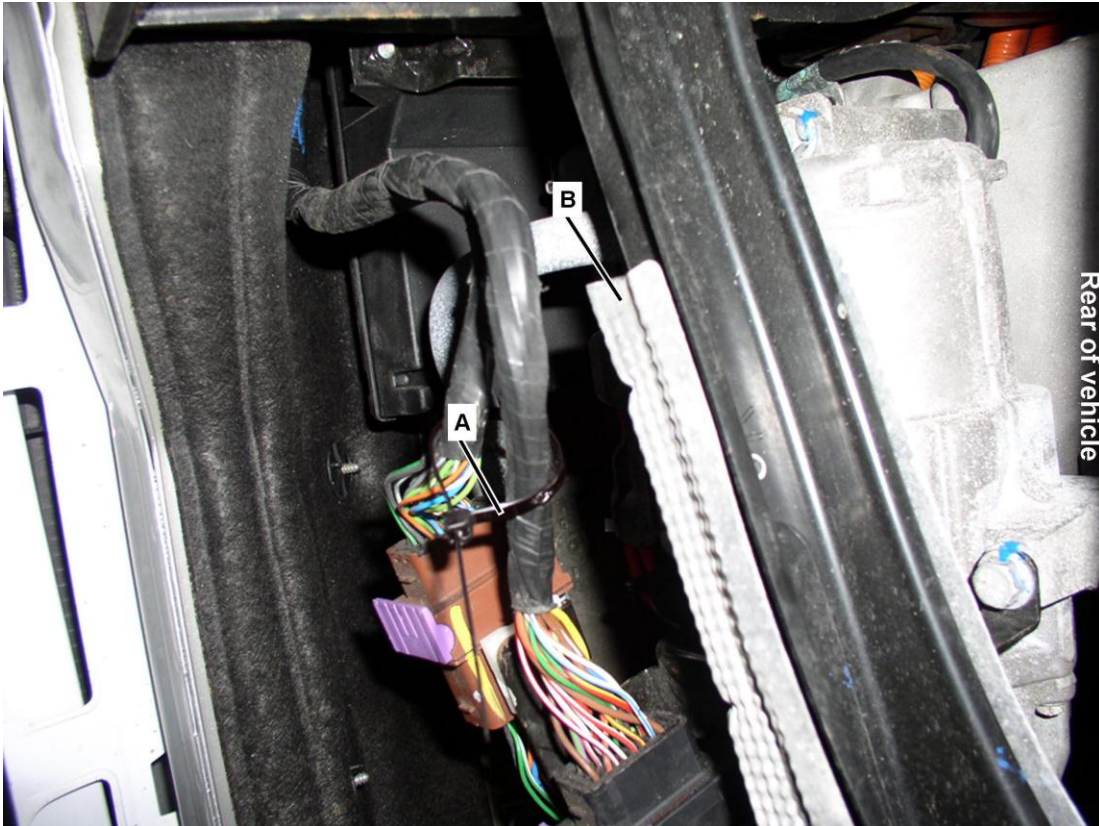
Figure 24
A: Cable tie
B: Shield

Ensure that sufficient space is left between the cable set and shield (see area B, Figure 24) along the entire length (contact with the wiring harness must not occur here).

1. Open tail gate.
2. Open service flap and place outside of vehicle.
3. Attach cable tie to cable harness in front area (see area A, Figure 24)
