Front seat backrest trim protrudes

Topic number	LI91.10-P-055704
Version	1
Design group	91.10 Front seats
Date	03-05-2013
Validity	Model series 207 and 204.3
Reason for change	
Reason for block

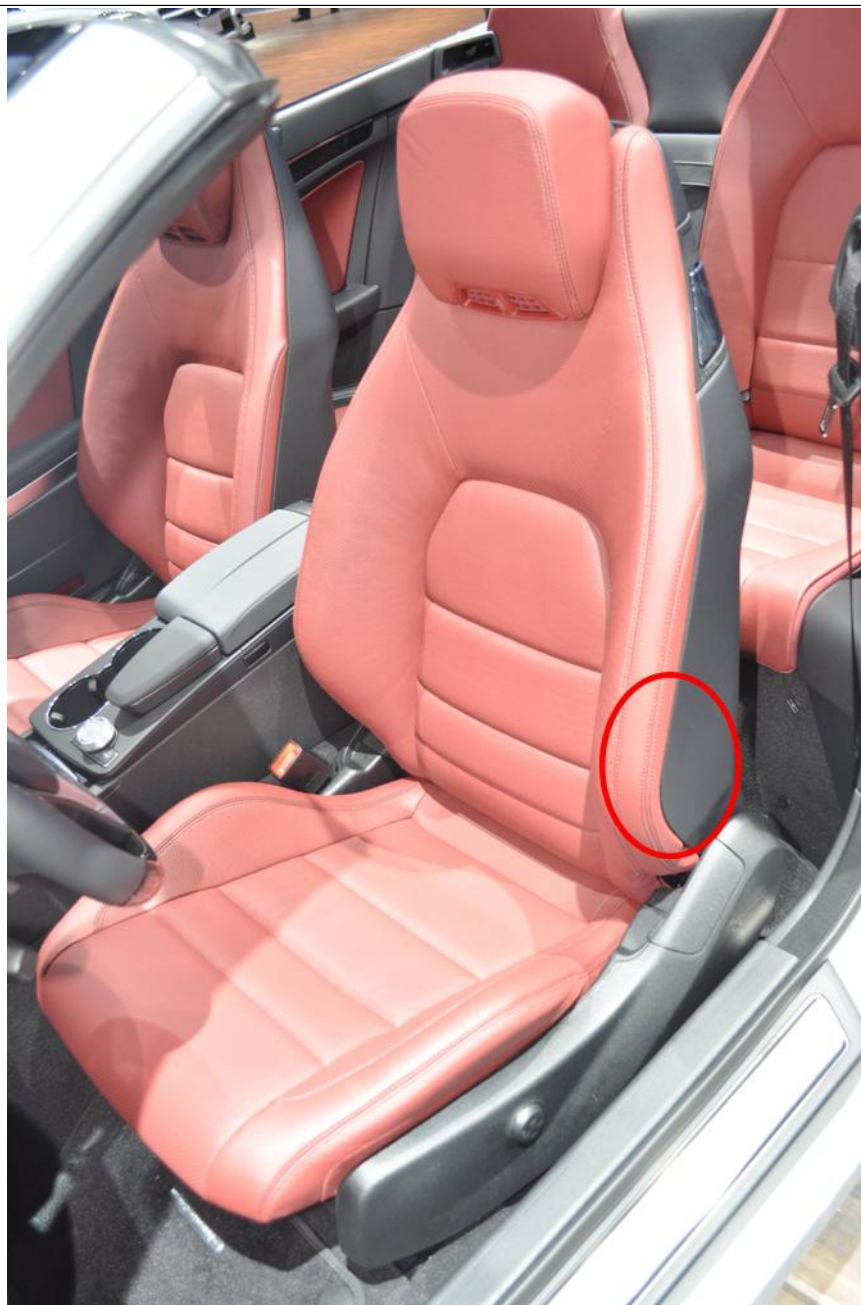
Pic0.jpg:

Gap forming between backrest cover frame and backrest padding in area of side bolster, trim protrudes (for area see Pic0).

Attachments	
File	Designation
Pic0.jpg	Area of gap formation Picture shows OK condition

Mounting clip loosening under load.

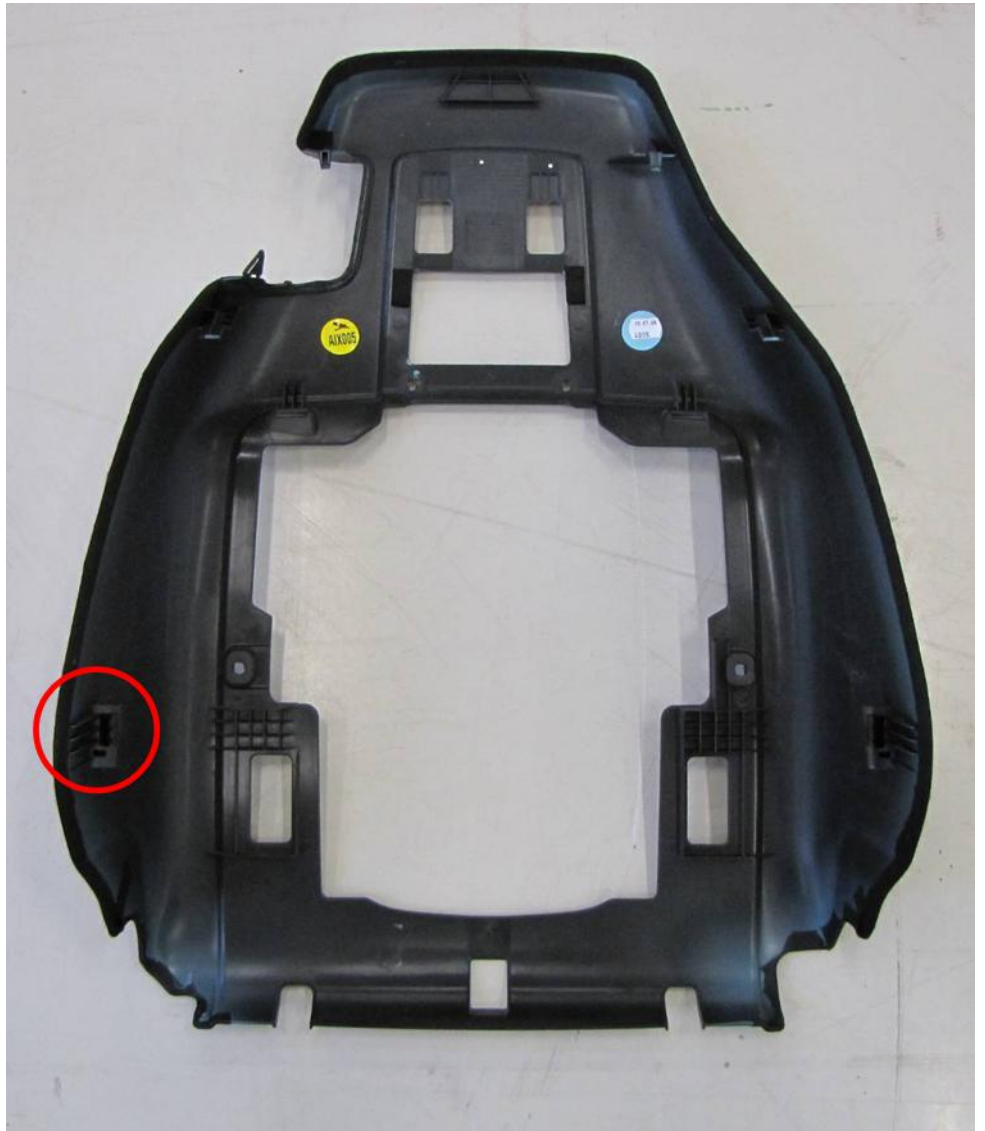
Pic1.jpg:

Attachments	
File	Designation
Pic1.jpg	Area of clip
Pic2.jpg	Gluing felt

Increase clip forces by gluing in a piece of felt (see Pic1).

To do this, detach seat-back lining as per instructions in WIS document AR91.10-P-1910CW and remove lower mounting bolts of cover frame.

The trim can now be pulled back at the bottom.
