Side windows make noise or reverse when closing

Topic number	LI67.30-P-052837
Version	1
Design group	67.30 Side windows
Date	01-20-2012
Validity	Model 166
Reason for change	
Reason for block

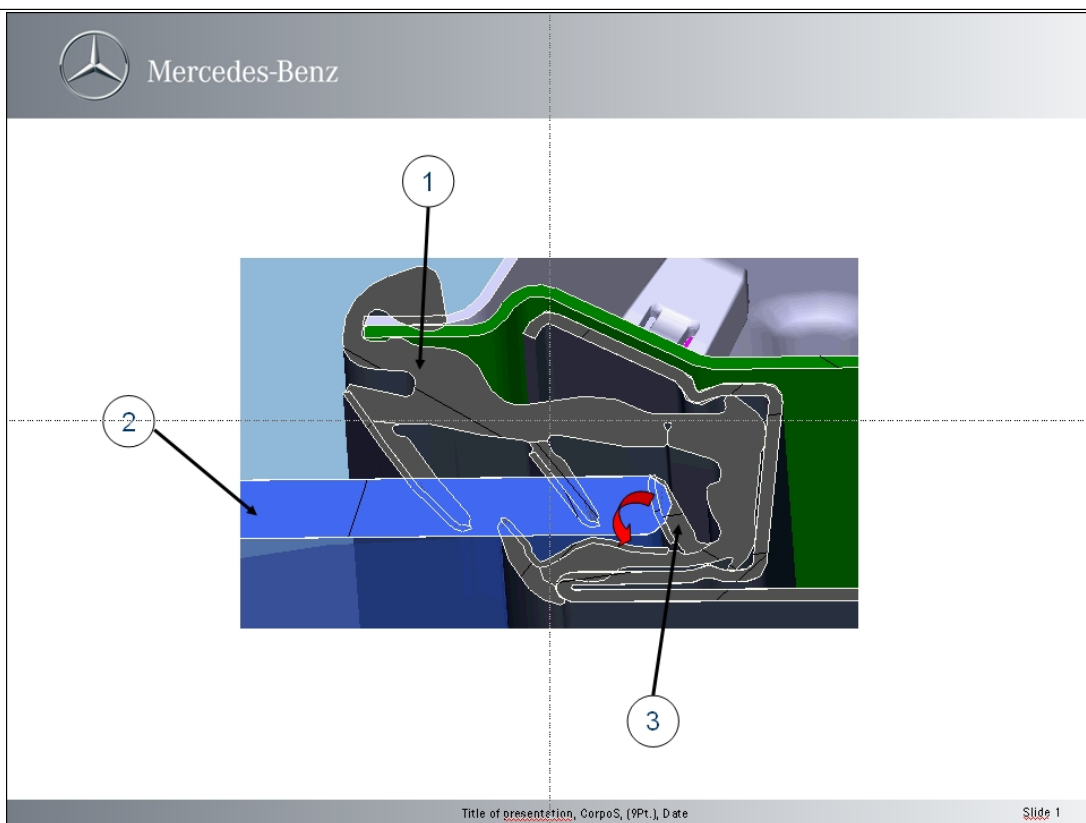
Bild1.jpg:

2. Window guide rails (see Picture 1): Side window (2) can slip behind base lip (3) whereupon the base lip (3) folds over (red arrow).

Consequence: Window runs on bare rubber and the friction is too large, which causes noise and reversing windows.

IMPORTANT: When installing the side window make sure that the base lip (3) is not positioned at the side of the window

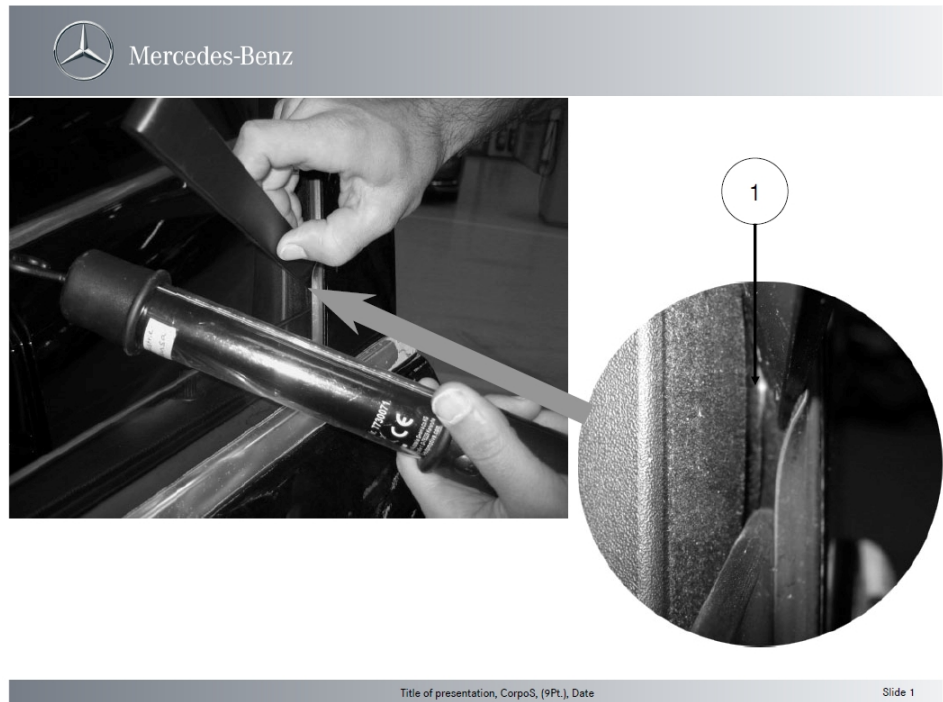
Bild2.jpg:

2. Visual inspection of window guide rails at front and rear as to whether the base lip has folded down (see Picture 2):

- Open window and close slightly again.

- Use a plastic wedge to force the window guide rail above the window until the base lip (1) is visible.

- If the base lip is folded down replace the affected window guide rails.

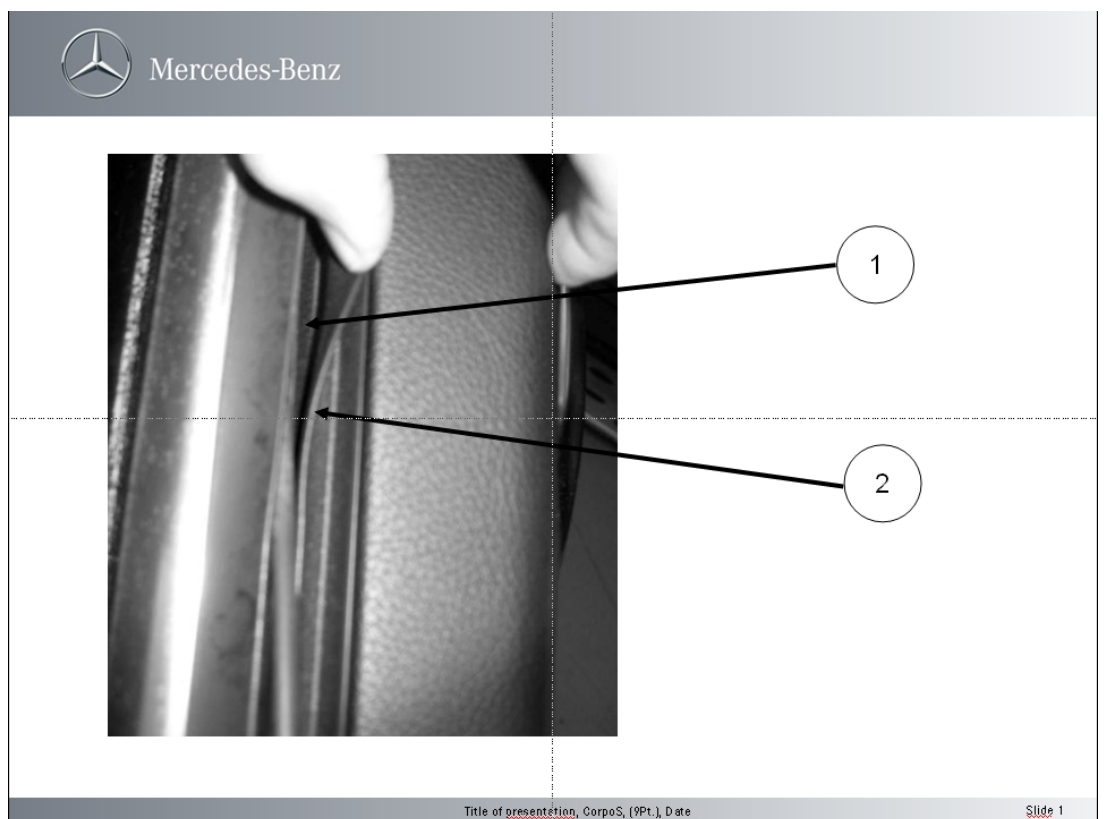
Bild3.jpg:

1. Interior dust shield seal: Faulty anti-friction coating can lead to increased friction and folding down of the sealing lips.

1. Visual inspection of upper (Picture 3, Item 2) and lower sealing lips (Picture 3, Item 1) of interior dust shield seals:

- If the sealing lip has folded down replace the affected interior dust shield seal.
