## Impairment of electrical folding function of 2nd seat row (SA code 843)

| Topic number | LI91.12-P-055797 |
| Validity | Model series X166 with SA code 843 (2nd seat row, electrically folding) |

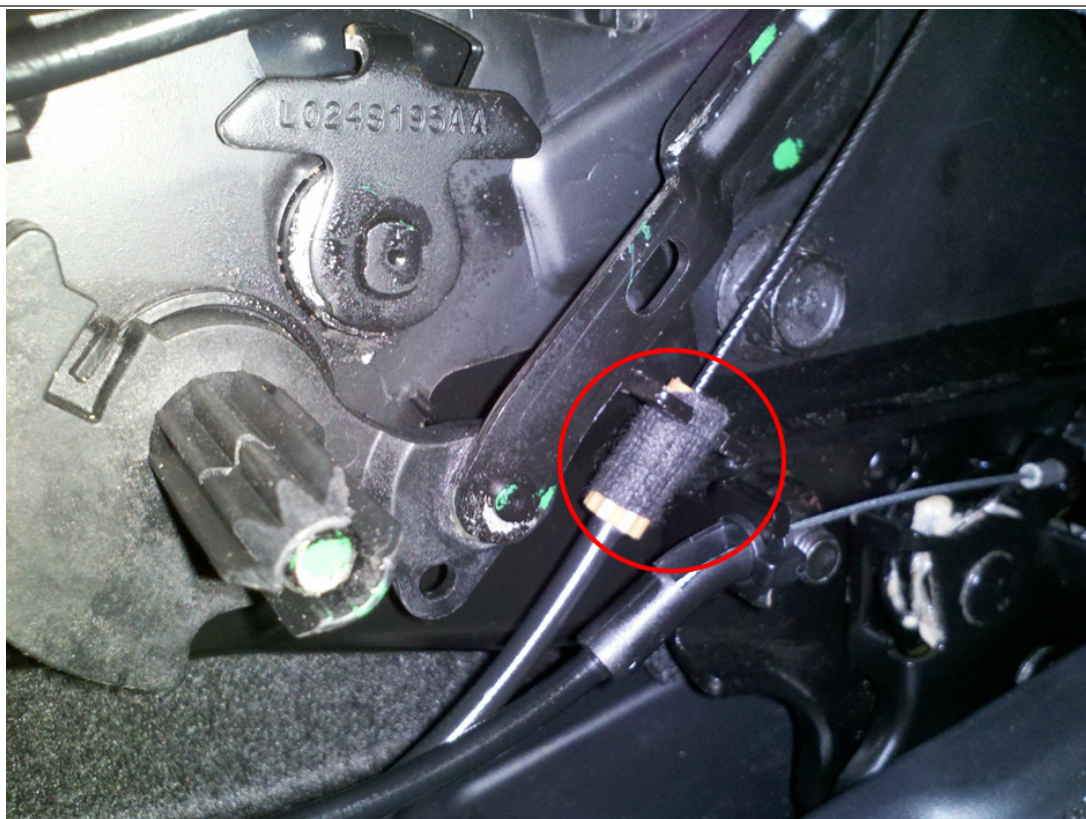
Pic1.jpg:

The cable (Bowden cable) of the electrical folding function can detach from the counterholder.

| Attachments | |
|---|---|
| Pic1.jpg | Remedial action, location of felt |

Installation of felt tape on the vinyl ring of the cable, as shown in the picture in the attachment.

1. Remove exterior lining, steps 1-10, as described in AR91.12-P-0100GQ
2. Wrap vinyl ring with felt tape and then press into counterholder of seat structure and fix in place. See Figure 1!

Trim felt tape as required.

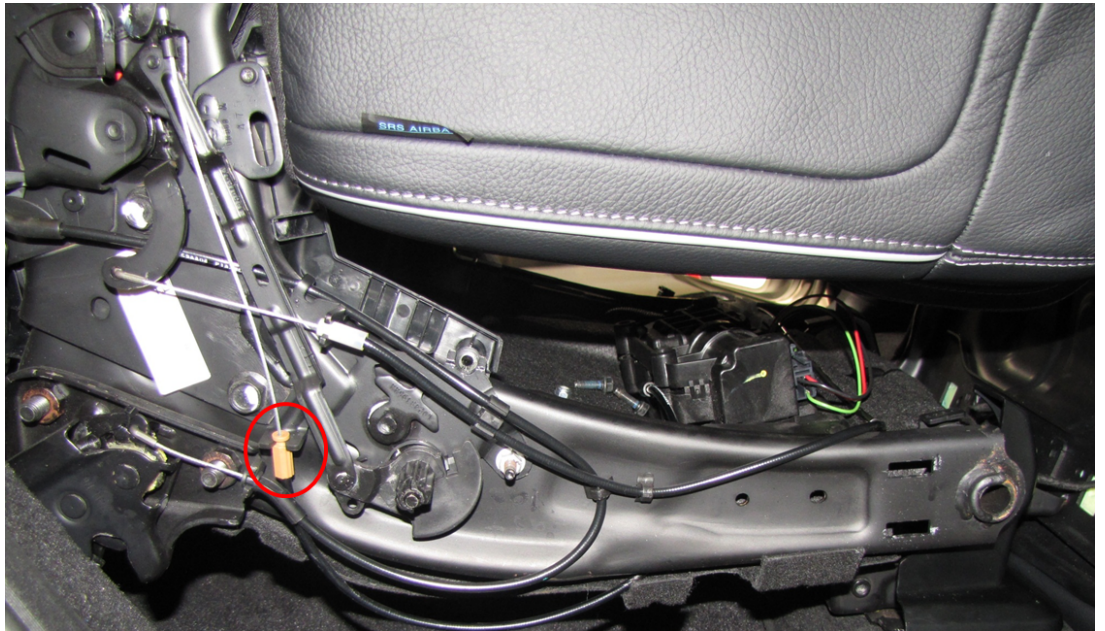
Pic2.jpg:

| Attachments | |
|---|---|
| Pic2.jpg | Overview of routing of cable (Bowden cable) |
