Service Campaign Bulletin

Campaign No. 2013020001, March 2013

SUBJECT: **Model X164, Model Year 2012**
Apply Seam Seal to the Right A-Pillar

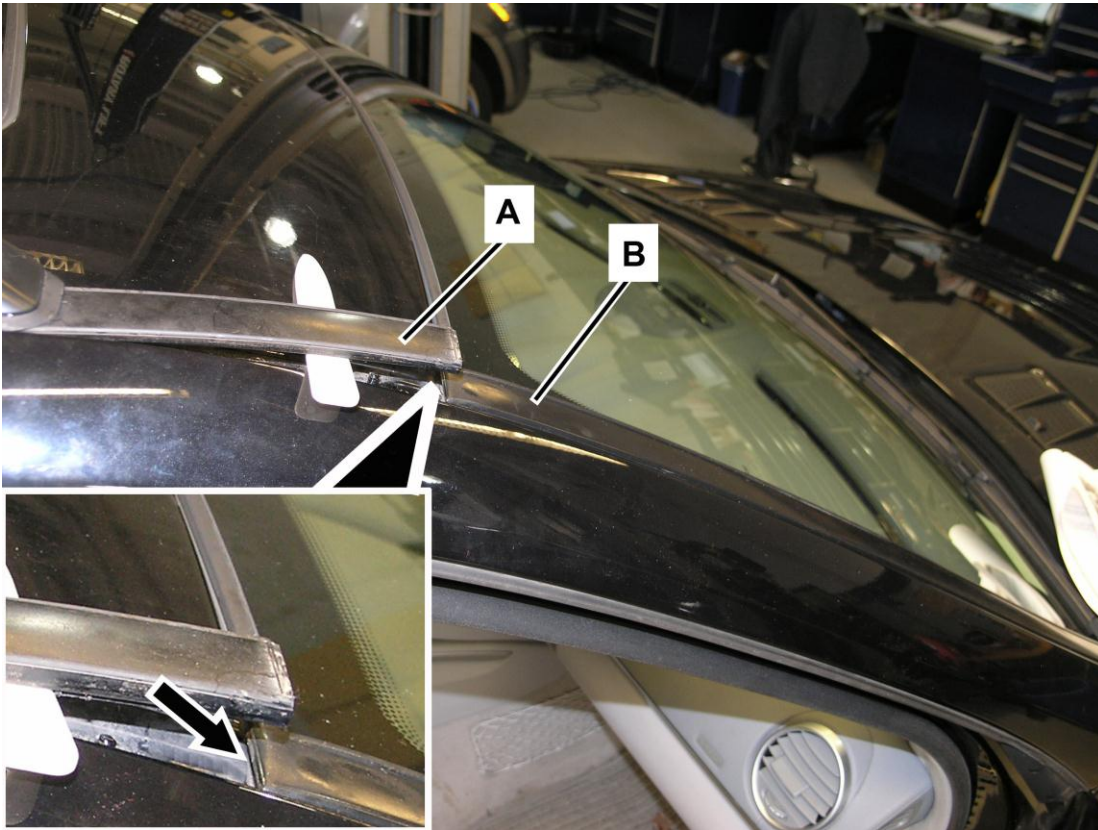
Figure 3

This Service Campaign has been initiated because Daimler AG (DAG), the manufacturer of Mercedes-Benz vehicles, has determined that the seam seal at the right A-Pillar may be missing due to a production issue. An authorized Mercedes-Benz dealer will apply seam seal on the right A-Pillar at the next workshop service.

4. Support roof molding (A, Figure 3) with plastic wedge.

5. Clean area (arrow, Figure 3) under water rail (B) to be reworked.

6. Apply seam seal to body seam (arrow, Figure 3) located under water rail (B) with an acid brush.

Do not attempt to lift or remove water rail (B) this will cause damage to the rail.

7. Allow seam seal to dry for approx. 20 minutes then apply touch-up paint.
8. Assemble in the reverse order.
