Countries:	AUSTRALIA, BRAZIL, CANADA, UNITED STATES, MEXICO, SOUTH AFRICA	Document ID:	IK0400077
Availability:	ISIS, Bus ISIS, FleetISIS, Body Builder	Revision:	12
Major System:	BRAKES	Created:	4/11/2011
Current Language:	English	Last Modified:	11/25/2013
Other Languages:	Français , Español ,	Author:	Anthony Kelso
Viewed:	5198

Title: FLR-10 Bendix Wingman fault. ACB display with SPN 886 FMI 7. Includes procedures for repeat misalignment failures on FLR-10 Radars

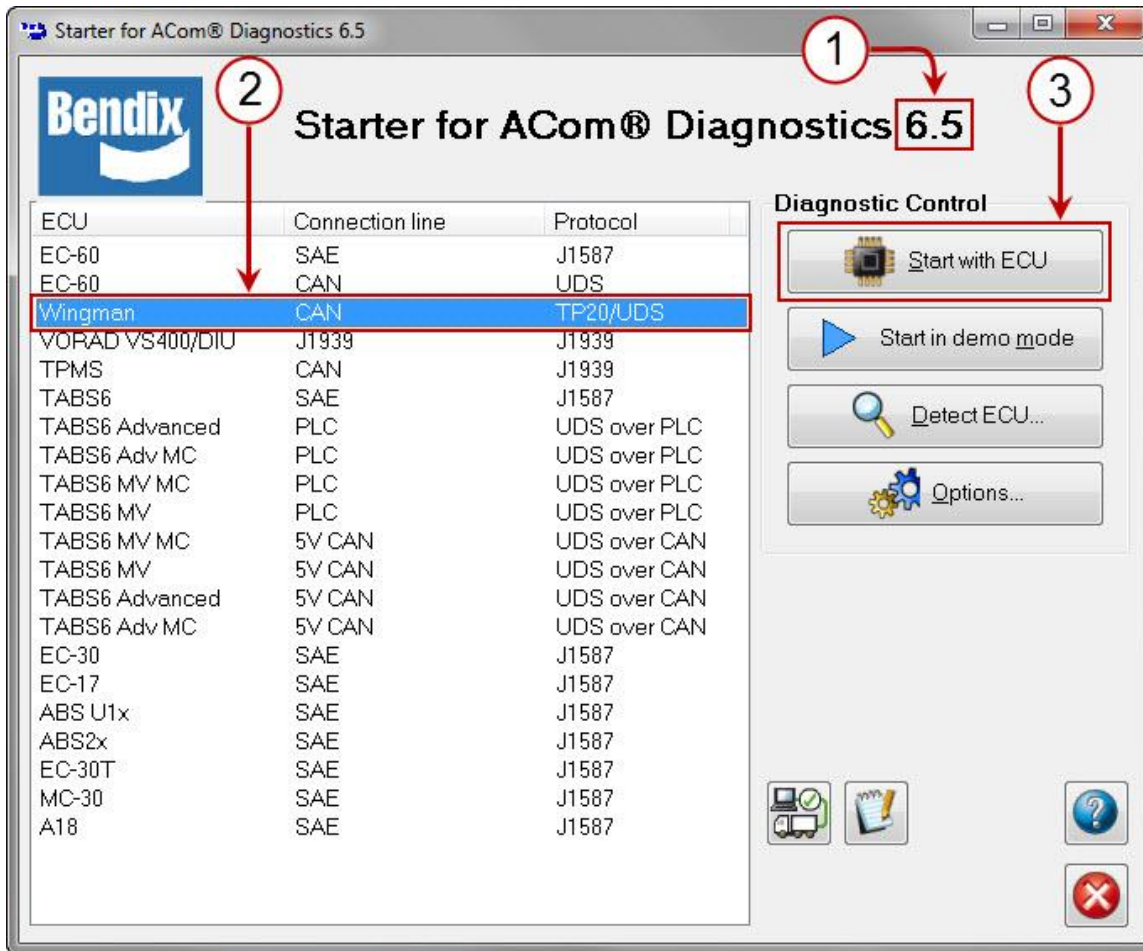
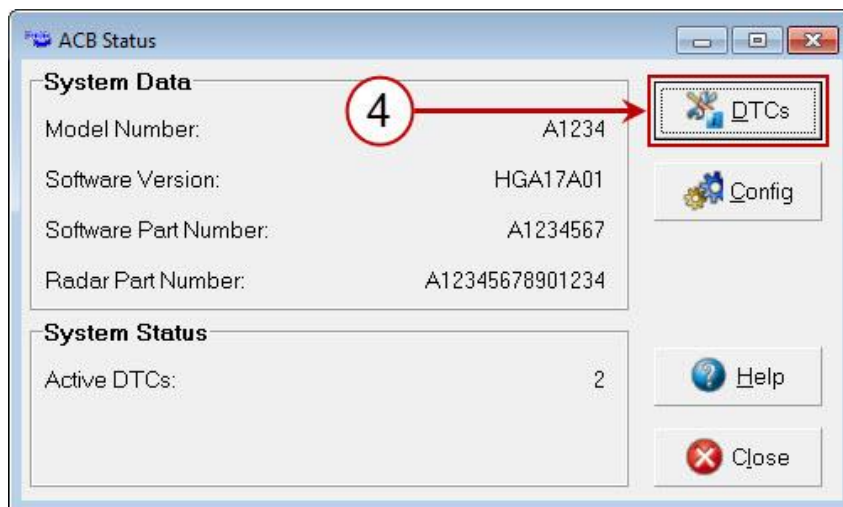
1. ACom Diagnostics software – Version 6.5 or later – is required.
2. Select "Wingman" from the starter screen
3. Select "Start with ECU"

4. Click "DTC" to show the diagnostic trouble codes.
5. If you are unable to connect to Wingman ACB in ACom, please follow [IK0400093](#)
