<b>Countries:</b>	AUSTRALIA, BRAZIL, CANADA, UNITED STATES, MEXICO, SOUTH AFRICA	<b>Document ID:</b>	IK0400093
<b>Availability:</b>	ISIS, Bus ISIS, FleetlSIS, Body Builder	<b>Revision:</b>	3
<b>Major System:</b>	BRAKES	<b>Created:</b>	10/28/2011
<b>Current Language:</b>	English	<b>Last Modified:</b>	11/4/2013
<b>Other Languages:</b>	<a href="#">Français</a> , <a href="#">Español</a> ,	<b>Author:</b>	Anthony Kelso
<b>Viewed:</b>	1441

**Title:** Bendix Wingman - unable to connect to ACB

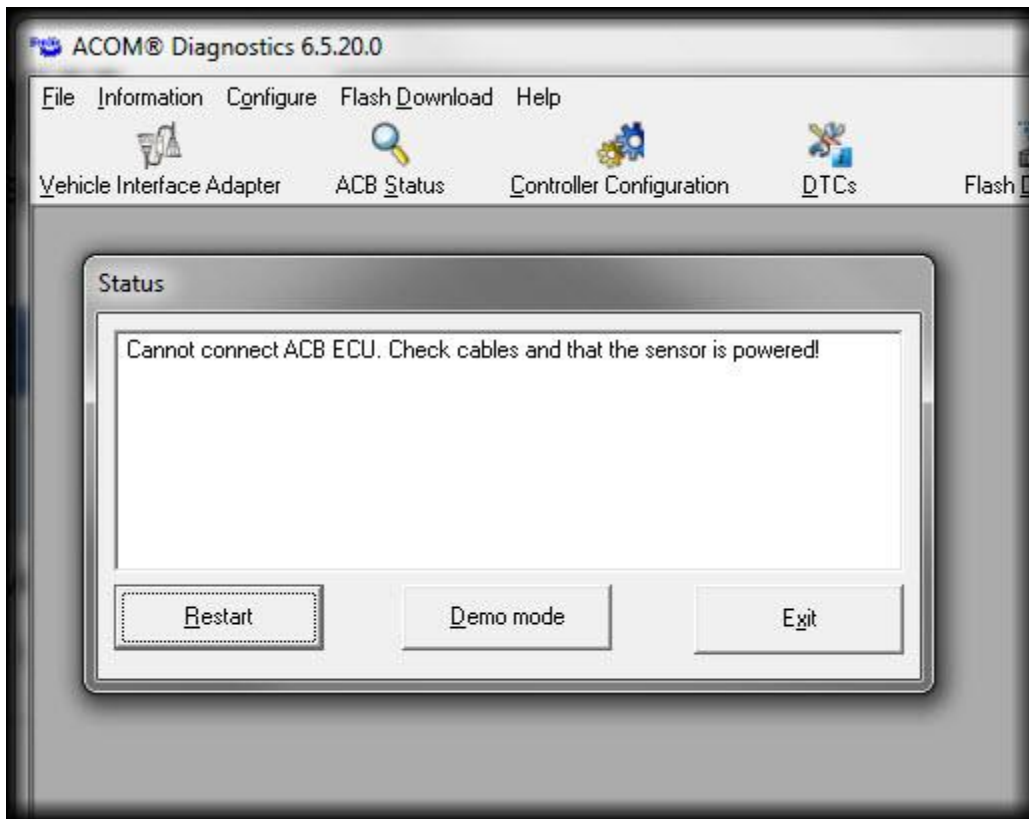
Unable to connect to Wingman ACB in Acom. No problems connecting to EC-60 side of ABS

Error box will display "Service Failed! Unable to connect! Check connections!"

Disconnect ECM / TCM fuse to eliminate data traffic. Then attempt to connect to the Wingman ACB Module in ACom.
