Title: MaxxFace DT, 9 & 10 electric fuel pump diagnostic tips

Applies To: EPA 2010 MaxxFace DT, 9 & 10

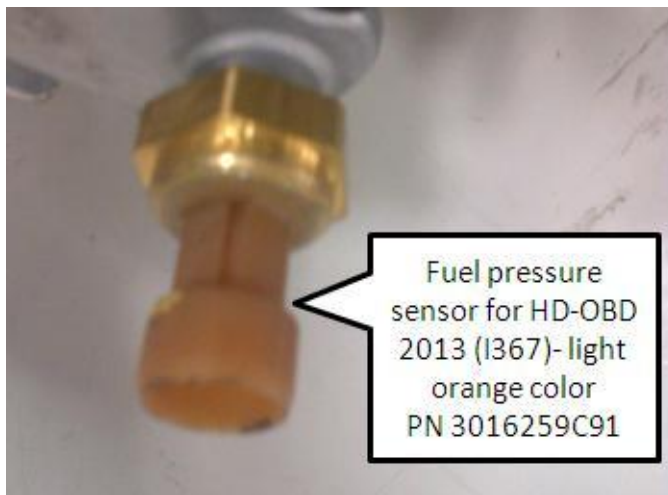
The ECM monitors the fuel delivery pressure sensor located on the bottom of the fuel filter housing. If the ECM determines that the pressure is low a diagnostic trouble code is set. EPA 2010 (I334) and HD-OBD 2013 (I367) use different fuel pressure sensors. **They cannot be interchanged.**

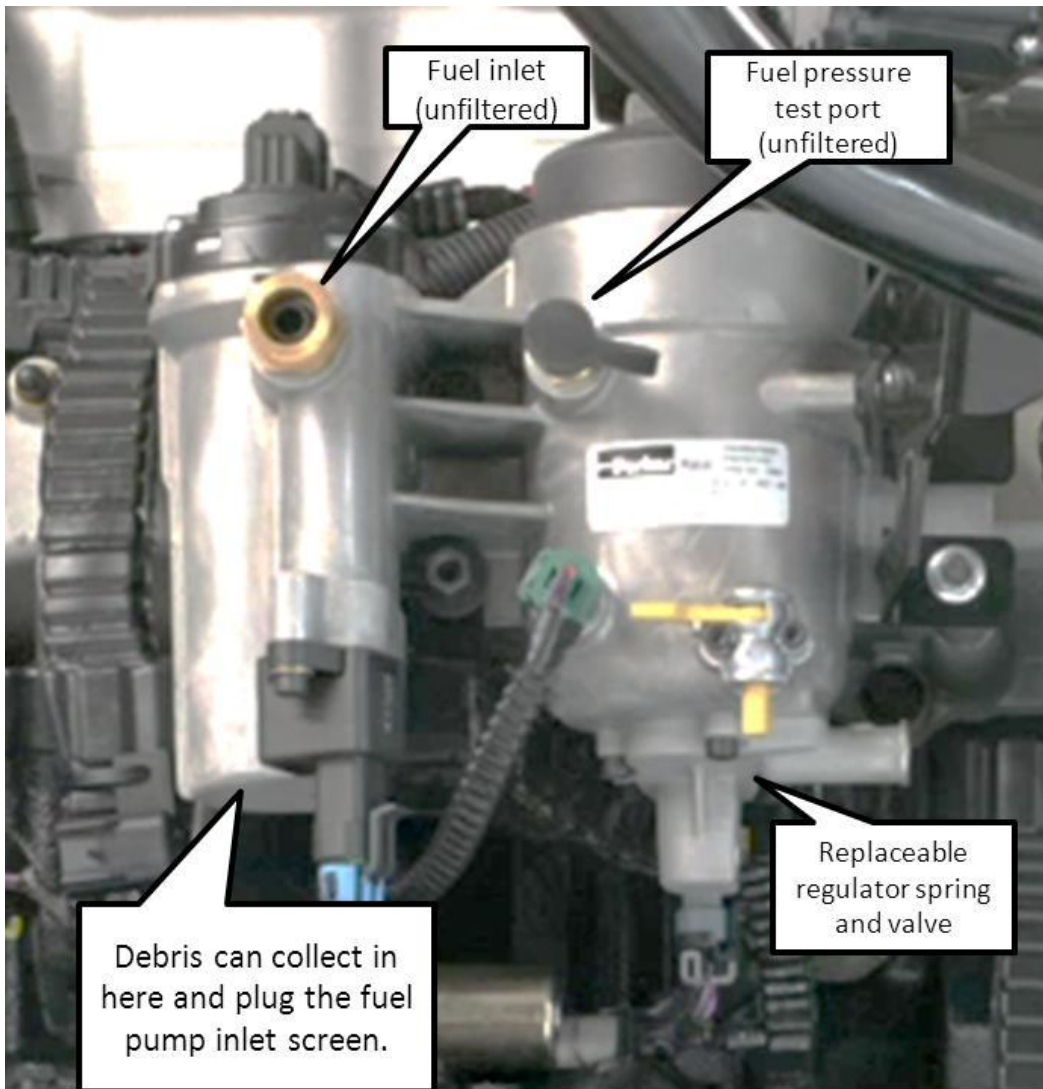
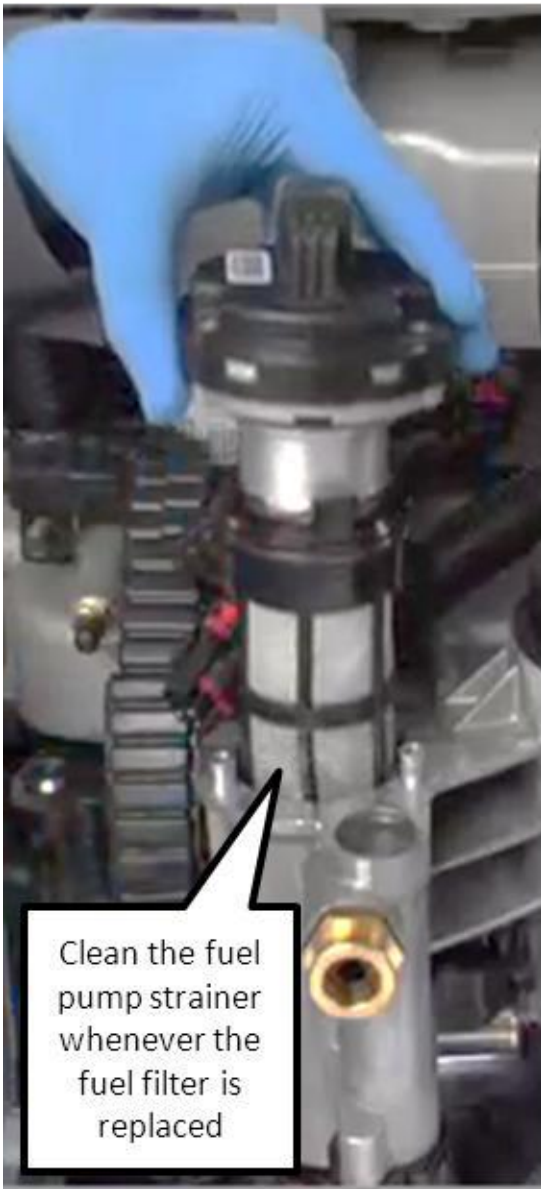
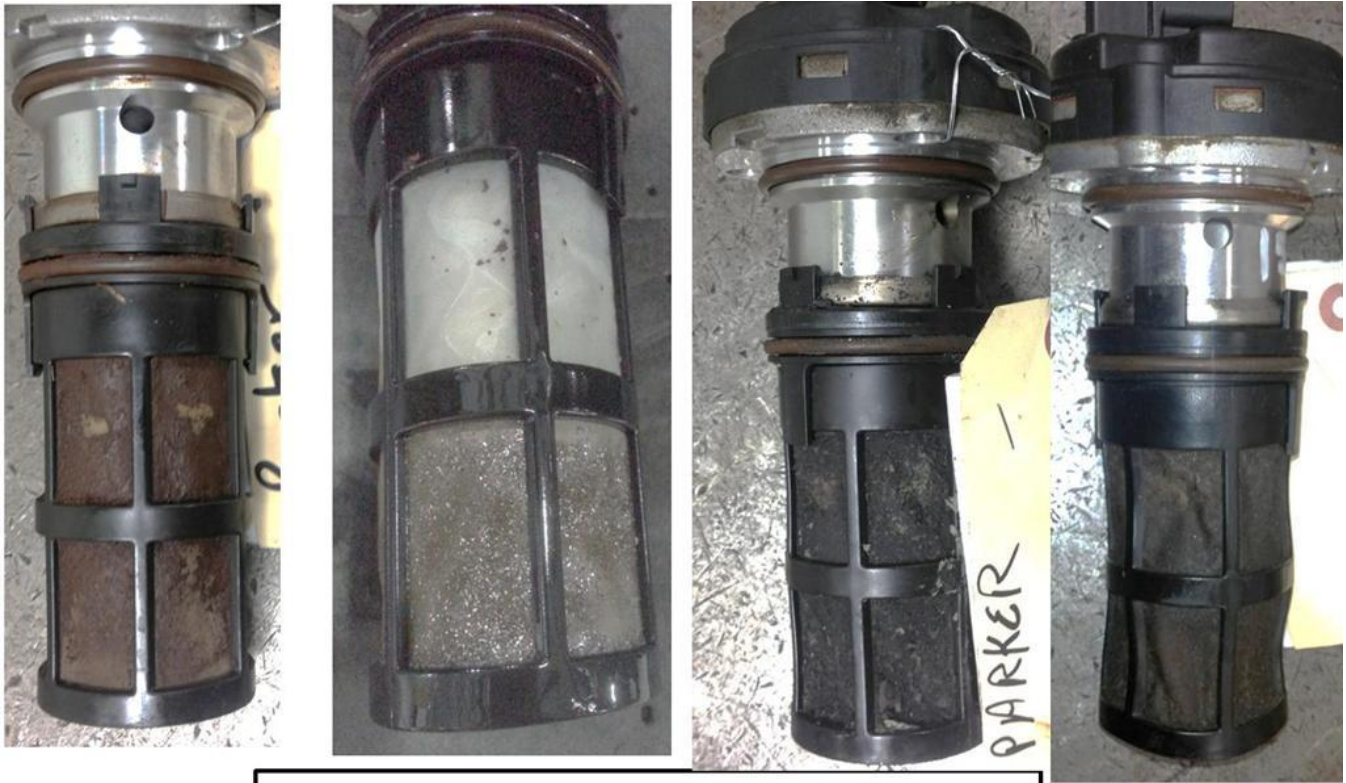
- Clogged fuel pump strainer (see image below)
- Worn fuel pressure regulator valve (serviceable)
- Plugged fuel filter element
- High fuel inlet restriction caused by plugged strainer, kinked fuel line, fuel pickup tube interference with fuel tank bottom, or tank debris
- Low voltage to fuel pump

These vehicles need the strainers replaced

The fuel strainer can be seen when the pump is removed from the filter module. The strainer should be serviced at the filter replacement interval (30K miles / 43K Km / or 12 months). The strainer P/N is 1899335C91
