Countries:	CANADA, UNITED STATES, MEXICO	Document ID:	IK1600202
Availability:	ISIS, FleetISIS	Revision:	0
Major System:	CAB / SLEEPER / HOOD	Created:	11/13/2013
Current Language:	English	Last Modified:	11/18/2013
Other Languages:	NONE	Author:	Patrick Gotschall
Viewed:	176

Title: Cowl tray seal

Applies To: TerraStar, DuraStar, WorkStar, TranStar, ProStar, LoneStar, AE/AC Bus built before 11/11/2013

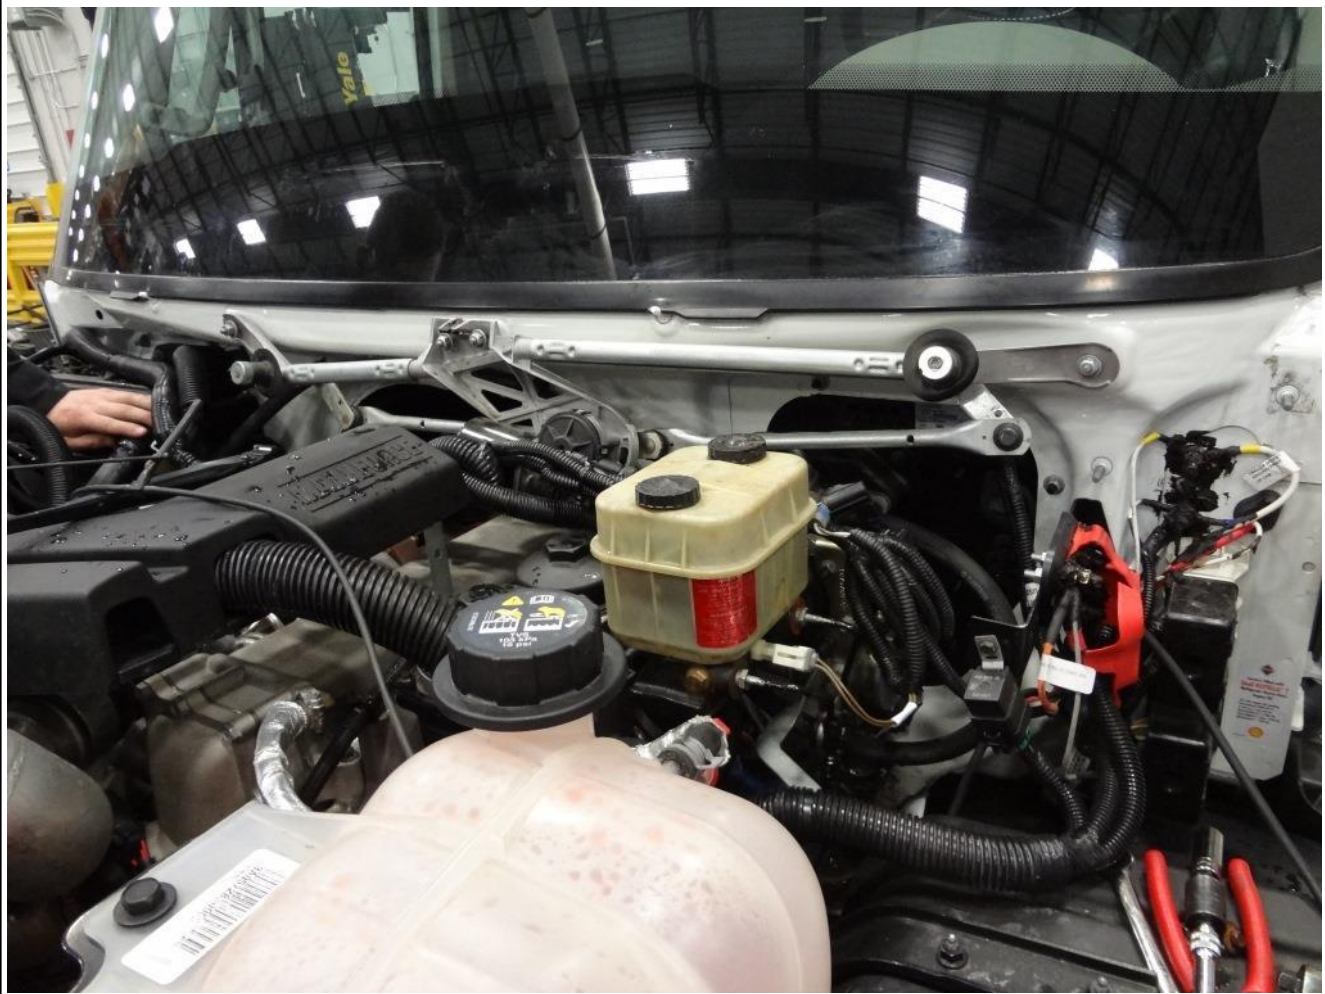
Cowl tray removed, no seal installed.
