NUMBER: 25-003-13

GROUP: Emissions Control

Malfunction Indicator Lamp Illumination Due To Oxygen Sensor

2011	(DJ)	Ram Pick Up (2500)
2011	(D2)	Ram Pick Up (3500)

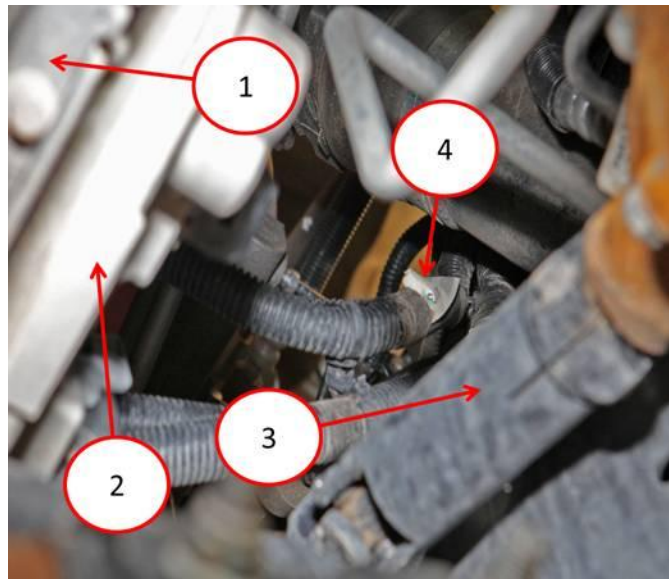
Fig. 1 LOCATION OF TRANSMISSION HARNESS TAG, VIEWED FROM BELOW

- 1 - Engine Oil Pan
 - 2 - PCM
 - 3 - Steering Shaft
 - 4 - Transmission Wiring Harness Tag Location
-

1. Determine if the Oxygen Sensor Module wiring harness terminals require replacement. Inspect the tag on the Transmission Wiring Harness for the part number suffix (the last two digits). This wiring harness tag is attached to the harness at a point usually most visible from under the hood. Initially, it is easiest to locate the tag from under the vehicle. Follow the harness from the PCM (front) connector up to the takeout that heads toward the driver's side of the vehicle. The tag is located on this takeout, near the frame rail, behind the left front wheel well splash shield. See (Fig. 1) and (Fig. 2) for tag location references.

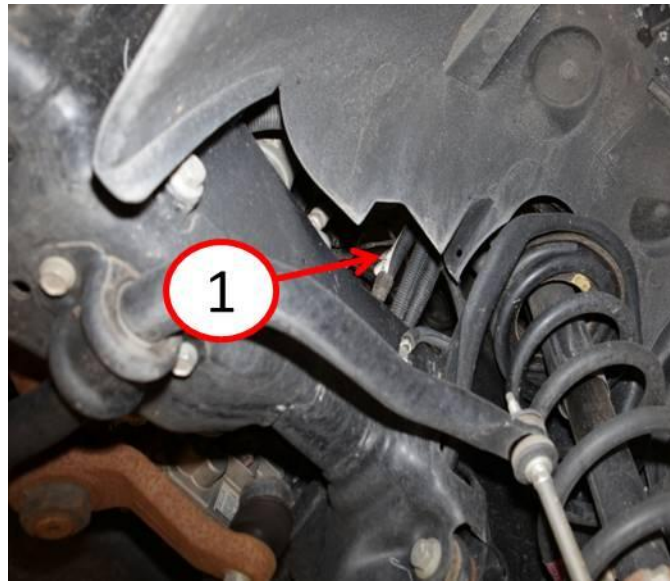
Fig. 2 TRANSMISSION HARNESS TAG, VIEWED FROM LEFT WHEEL WELL

1 - Transmission Tag as Visible Through Drivers Side Wheel Well

2. The harness part number is located on the left side of the tag between the two bar codes. Does the part number end with the suffix AC ?
 - a. Yes >>> If the suffix is AC, The Repair Procedure for Module Connector **IS** required. Perform the repair procedure below.
 - b. No >>> This bulletin does not apply. Ensure SB's 25-004-12 and 18-012-12 REV. A (or later bulletins) have been completed.

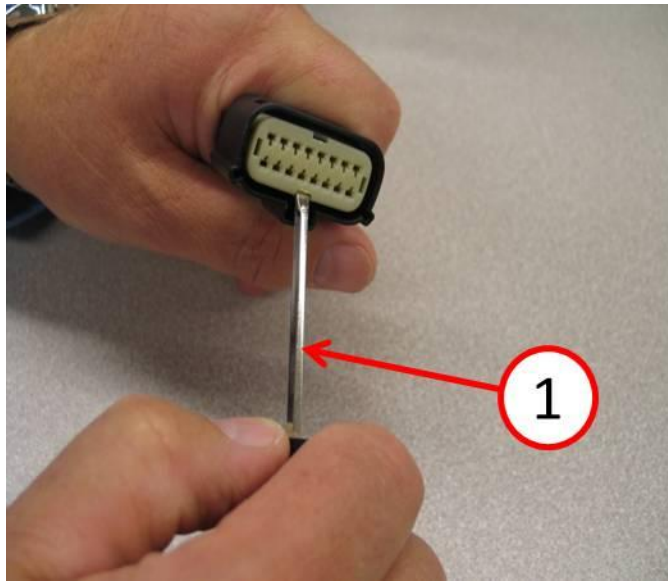
Fig. 3 PRY OUT THE TPA 5MM

1 - Small Blade (3mm Wide Max) Screwdriver

1. Open hood.
2. Disconnect and isolate both negative battery cables.
3. Raise and support vehicle on a suitable hoist.
4. Disconnect the **Oxygen Sensor Module Connector** and remove the protective tape and plastic shield on the connector.
5. Using a narrow blade, flat screwdriver (3 mm wide max), pry the white TPA (white cover seen when looking in connector). Notice the travel of white TPA is only 5 mm or until a "click" is heard. This is the release point of the TPA. The TPA is a device that locks the release finger so that when seated, terminal will not and cannot be disengaged, (Fig. 3) and (Fig. 4).

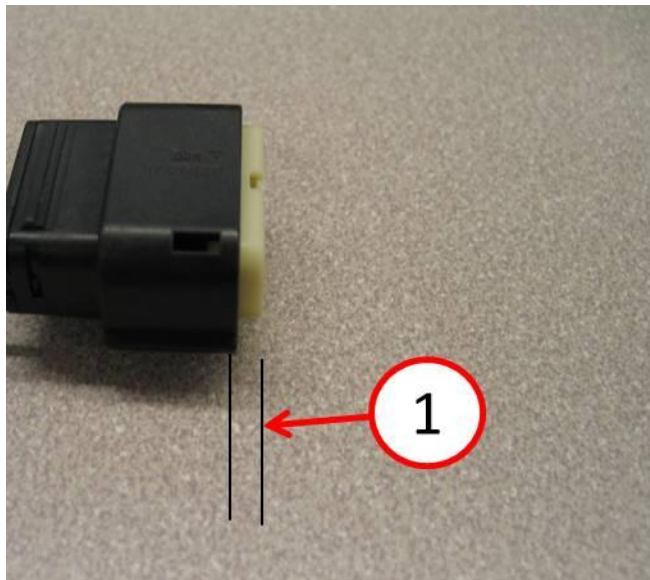
Fig. 4 TPA EXTENDED 5MM

1 - Extend TPA 5MM Only

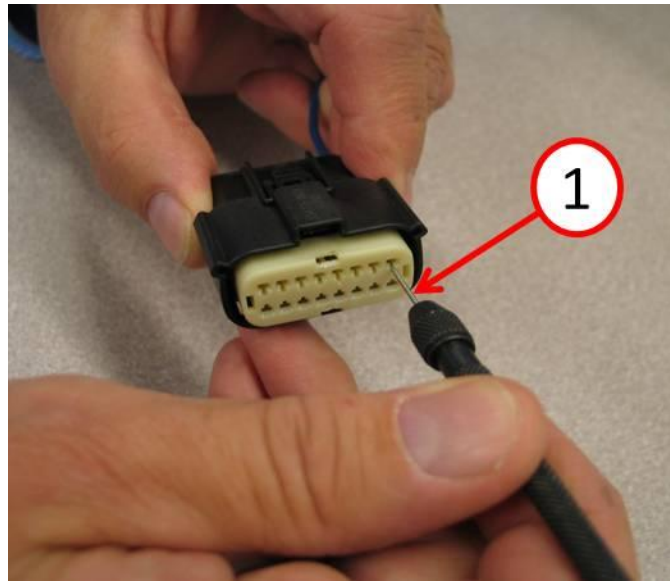
Fig. 5 TERMINAL RELEASE TOOL INSERTED

1 - Tool Inserted to Release Terminal From Connector

6. Insert either J-38125-217 (Kent Moore number) OR MX 150-MX150L / 63813-1500 (Molex) OR a fabricated tool, (consisting of a chamfered 1mm drill bit installed with the cutting end of the drill in the handle of Miller Tool #8351), into TPA (module side of connector) into the desired "service port" until resistance is felt. (Fig. 5)

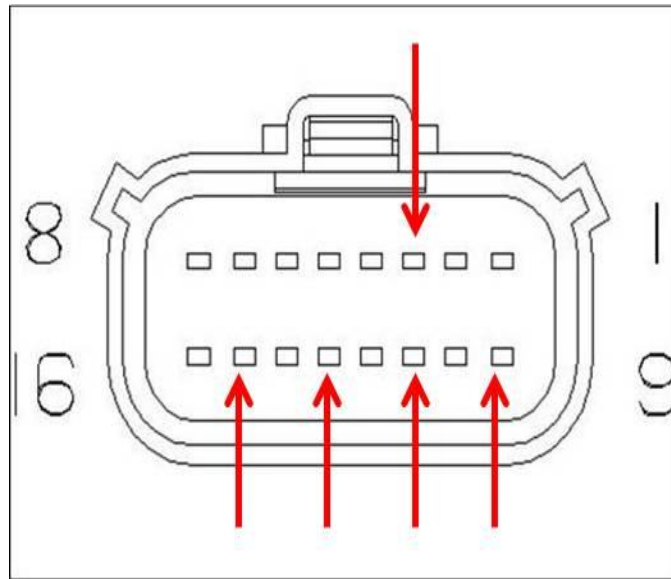
Fig. 6 TERMINALS TO BE REPLACED

This bulletin involves **inspecting for the part number of the transmission harness and based on the part number suffix, determining if the Oxygen Sensor Module Connector requires repair.** Some model year 2011 harness' were built with tin plated terminals in 5 of the connector cavities that should have been gold plated. Based on the transmission harness part number, the terminals will be replaced as required.

Replace Terminals Indicated By Red Arrows

8. Replace terminals #3, 9, 11, 13 & 15 (one at a time) as called out with RED ARROWS in (Fig. 6) with the gold terminal / pigtail included in Wire Repair Kit, p/n 68203454AA. The pigtail splice points should be staggered to eliminate bulk in the harness;

- a. Cut each wire, (one at a time) in a staggered manner.
 - b. Slide heat shrink tube on wire prior to splicing. Strip insulation on each wire and crimp together using band clamp **BEFORE SOLDERING** using Mopar splice band tool, p/n 05019912AA (or equivalent) then solder the crimped connection and heat shrink each wire individually.
