**NUMBER:** 08-007-13 REV. A

RB5 RE2 Loss Of satellite Function, Sirius ID Number Missing

2012-**\*\*2013\*\*** (JC) Journey

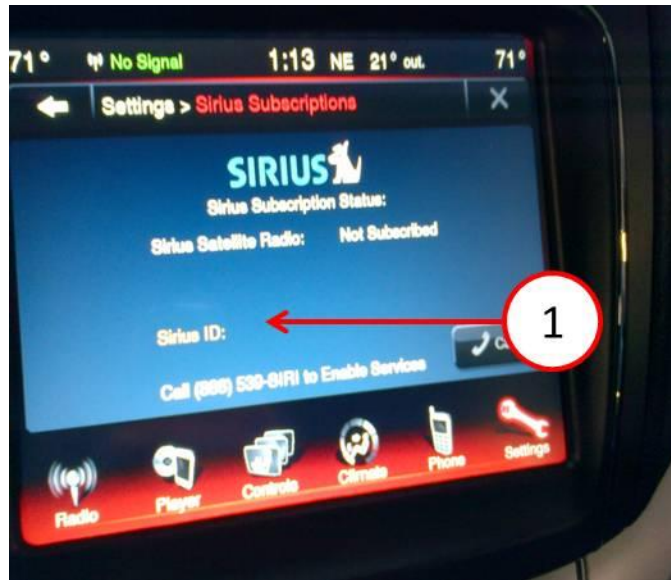
**Fig. 1 Sirius ID Number Missing**

A customer may experience a loss of satellite radio functions. **\*\*On further inspection the Technician may note that the Sirius ID number is missing\*\*.**

1. \*\*Are all satellite radio functions inoperative and is the Sirius ID number missing, see (Fig. 1).

1 - A Sirius ID number should always be in this location\*\*.

Updating the radio software will prevent this condition from occurring. If the customer has lost all satellite radio functions and the Sirius ID number is missing, the TGM will need to be replaced to repair this condition.

- a. Yes <<< Replace the TGM, proceed to [Step #2](#).
  - b. No <<< Update the radio software, proceed to [Step #4](#).
2. Replace the TGM per TechConnect - 08 - Electrical/8E - Electronic Control Modules/MODULE, Telematics Gateway/Removal and Install.
