NUMBER: 08-021-13

GROUP: Electrical

DATE: March 29, 2013

Flash: Hands Free Module Customer Satisfaction Enhancements

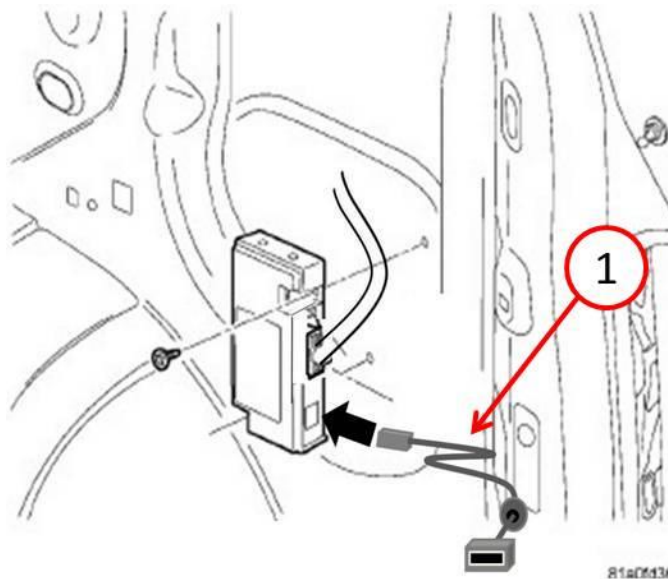
Fig. 11 USB Harness Connection

1 - USB harness PN# 82212160 or 68086985AB.

- 1. Access the HFM Module by following the installation instructions call out above.
- 2. Do **NOT** disconnect the electrical connectors from the HFM.
- 3. Connect the USB harness as shown in ([Fig. 11](#)).
- 4. Return to the Perform Software Reflash Procedure [Step #14](#).
