Title: Oil Carryover Inspection

Applies To: MaxxForce 11 and 13L

2010 MaxxForce 11 & 13L Oil Carryover

ESN: 4100000 and UP

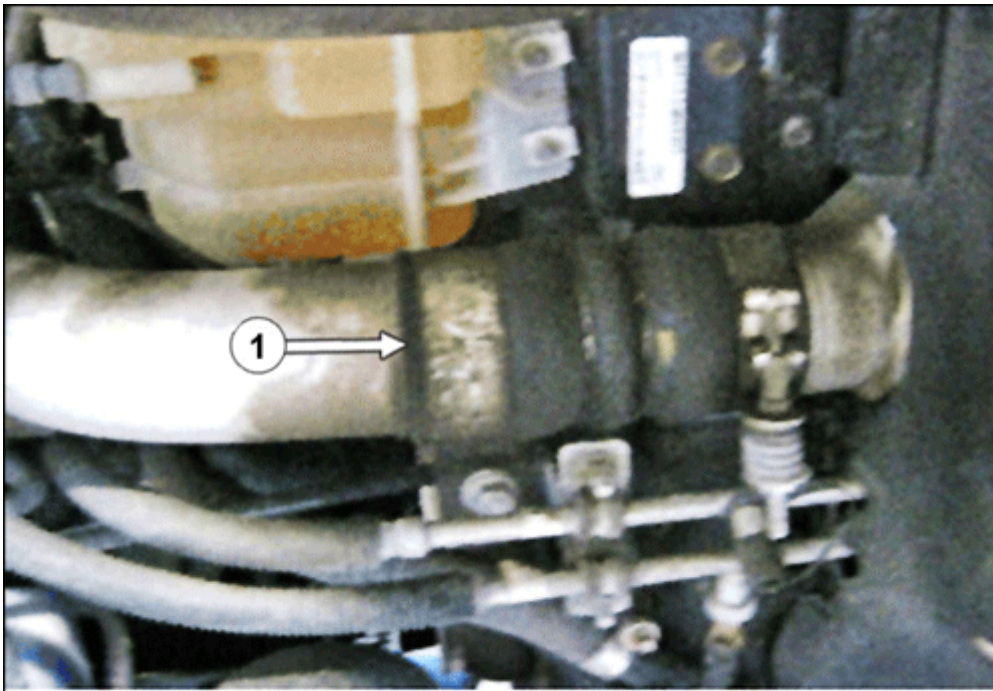
Figure 1

Some field vehicles have been found with oil carryover from the high pressure turbocharger outlet, to the inlet of the high pressure charge air cooler. If this issue is present, you will see oil seepage at the joint connecting the high pressure turbocharger piping and the inlet of the high pressure charge air cooler.

1. Oil Seepage at Joint

NOTE: If seepage is found, please verify there are no external oil leaks. If no external oil leaks are found please verify oil is being carried over from the high pressure turbocharger. If oil is found to be carrying over, please inspect the quality of the high pressure turbocharger as outlined in the 465 Service Manual located on ISIS.

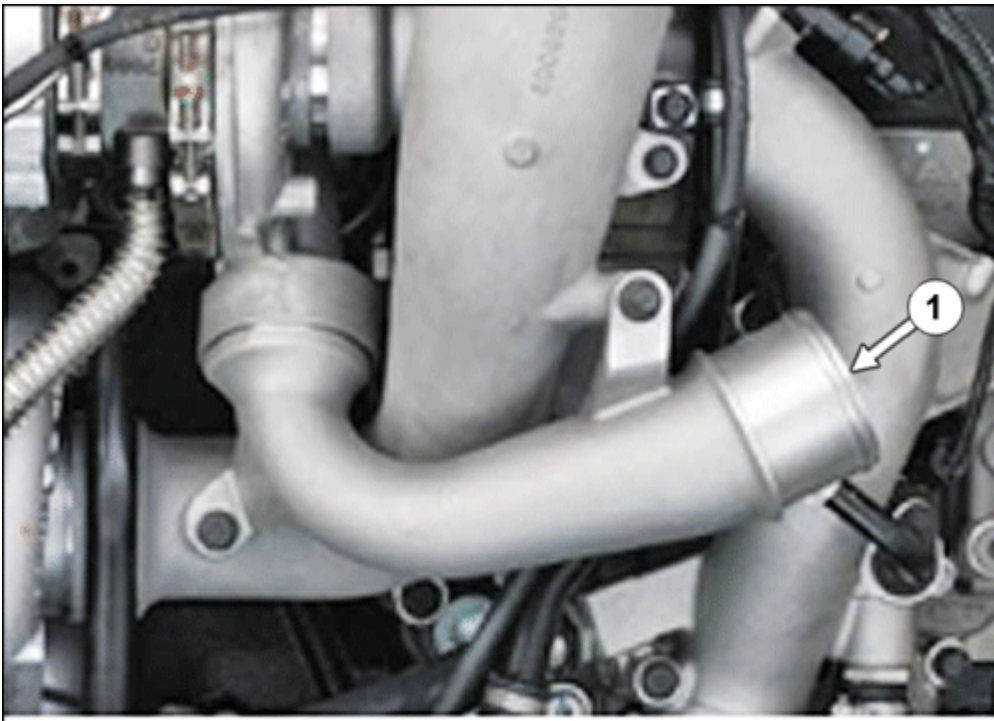
Figure 2

1. High pressure turbocharger outlet duct

4. Inspect the high pressure turbocharger outlet duct.

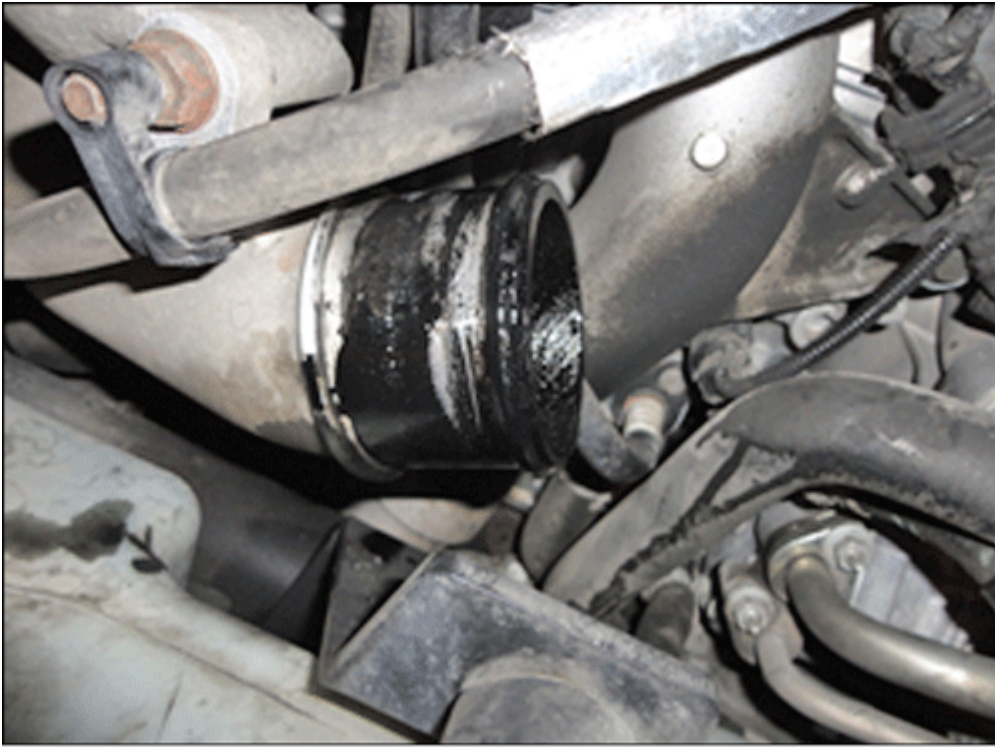
Figure 3

*Oil carryover from the high pressure turbocharger through the high pressure turbocharger outlet duct.

ATTENTION: If wet oil residue is not found at the high pressure turbocharger outlet duct, no further oil carryover diagnostics is needed.
