Title: Washers addition to water pump pulley bolts

Applies To: MaxxForce® DT, 9, & 10 EPA 10

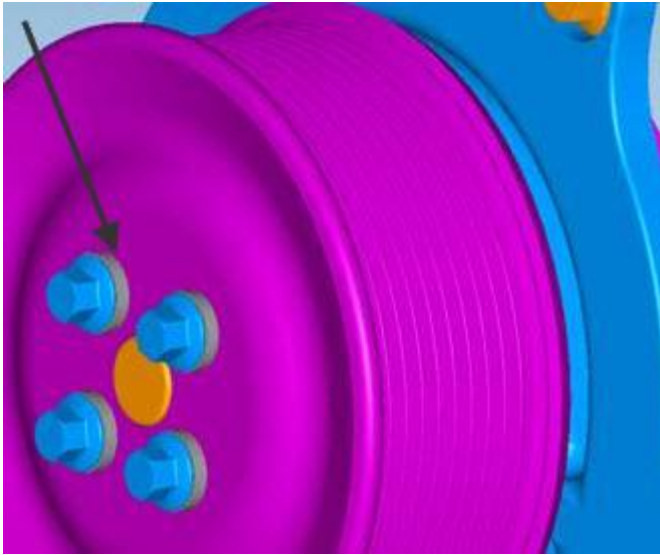
There have been some cases reported of water pump pulleys loosening on the MaxxForce® DT, 9, & 10 EPA 10. When this occurs, it is often caused by friction between the bottom of the hex head and the powder coated surface of the pulley. When the bolt is tightened to specification, this excessive friction will cause the bolt not to receive proper tension.

When the four bolts on water pump pulley are removed, each of them should be reinstalled with a washer and tightened to a different specification.

- 2.5mm M6 Washer: 30210R1 (quantity: 4)
- Torque specification: 133 lbf-in (15nm)
