NUMBER: 23-006-13

Waterleak At The Rear Of The Headliner

****2009 - 2012**** KK Liberty

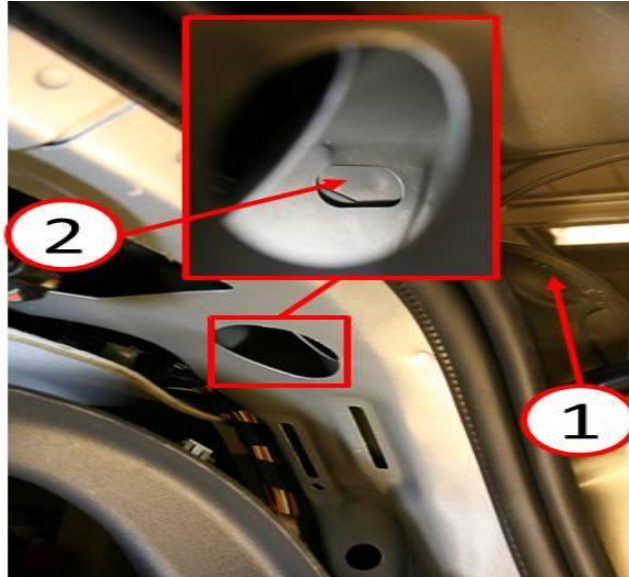
Fig. 2 Waterleak Inspection - Right Side Shown

2. Perform a water flow test for 20 minutes at the rear of the vehicle and inspect for any water leaking at the rear inner quarter panel of the right and/or left side as shown in (Fig. 2).
3. Was there any water leaking?
 - a. Yes >>> Proceed to [Step #4](#).
 - b. No >>> Continue further diagnosis, this bulletin does not apply.

- 1 - Right Rear Quarter Panel
 - 2 - Suspect Water Leak Area
-
