NUMBER: 23-008-13

Left And/Or Right Door High Closing Effort

2010- 2011	(KA)	Nitro
2010- 2012	(KK)	Liberty

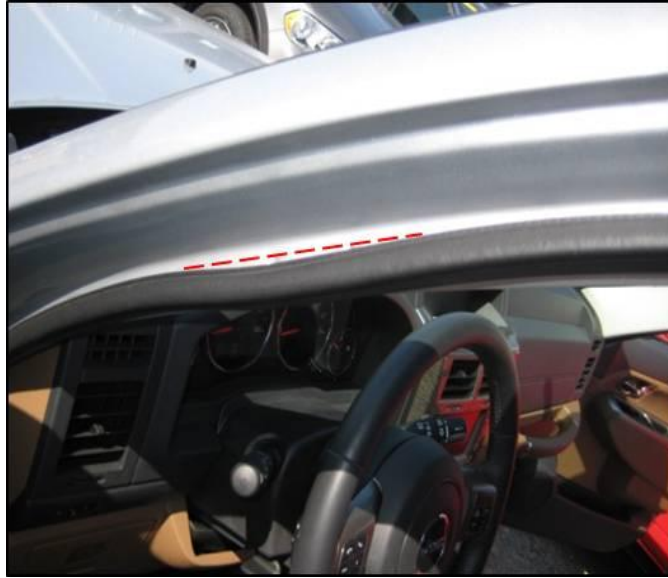
Fig. 1 Inspect Seal Placement

NOTE: Seal should be fully seated all around the door perimeter.

1. Open the door and check the body mounted seal for proper installation and correct as necessary ([Fig. 1](#)).

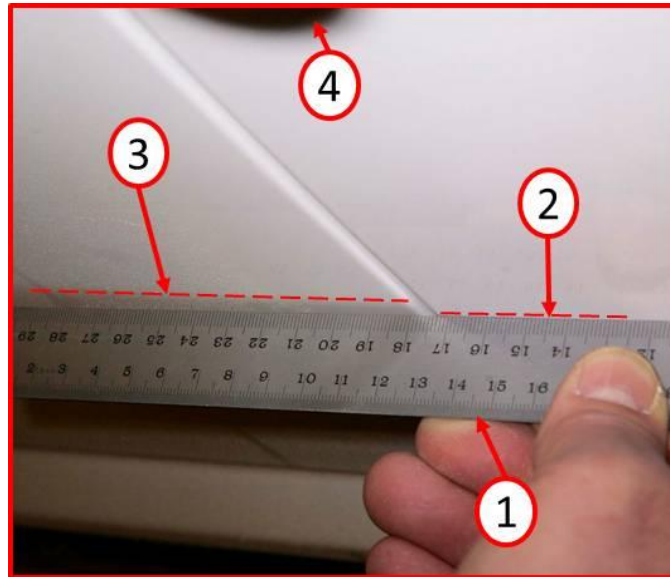
Fig. 2 Check Flushness

-
4. Is the suspect front door(s) under or overflush to the rear door(s)?
 - a. Underflush >>> Proceed to [Step #7](#).
 - b. Overflush >>> Proceed to [Step #5](#).

3. Fully close the suspect door(s) and carefully check front to rear door flushness using a straight edge/rule (1) across the front door (2) and rear door (3) surfaces near the latch level ([Fig. 2](#)).

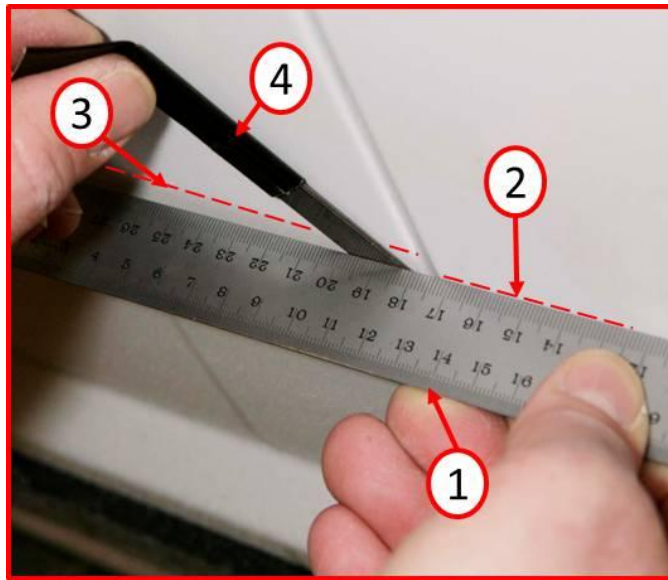
Fig. 3 Measure Overflush

NOTE: Maximum overflush should not exceed 1 to 1.5mm (.039"-.059").

-
6. Is the front door overflush to the maximum specification of 1 to 1.5mm(.039"-.059")?
- a. Yes>>> This bulletin does not apply, continue further diagnosis.
 - b. No>>> Proceed to [Step #7](#).

5. Using a feeler gage or equivalent, carefully determine the amount of front door overflush (Fig. 3).
