NUMBER: 23-010-13

GROUP: Body

Water Dripping Across Door Sill And/Or Damp Front Floor

2011 - 2012 (JK) Wrangler
 2011 - 2012 (J3) Wrangler (Export)

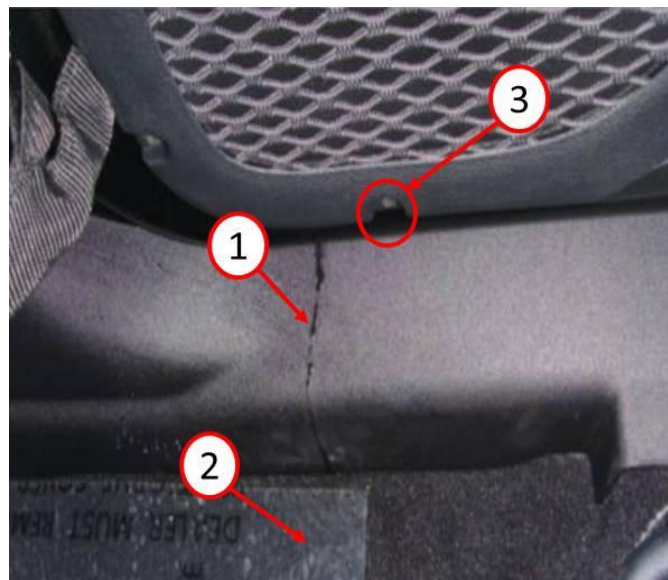
Fig. 1 Water Leak Path

The customer may experience water dripping across the door sill and/or a damp front floor.

- 1 - Front Door Sill (Waterleak)
- 2 - Front Floor
- 3 - Door Panel Front Lower Fastener

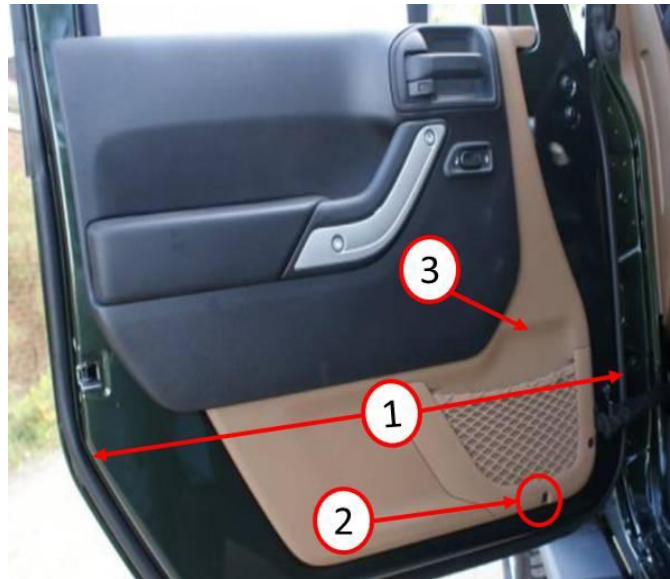
Fig. 2 Door Seal Modification Location

- 1 - Door Seal
- 2 - Door Panel Lower Fastener (Notch Location)
- 3 - Door Panel

1. Open the door on the side with leak present and mark the door seal (1) approximately below the lower door panel fastener (2) or the area where water is running across the sill([Fig. 2](#)).
2. Remove the lower section of the door seal (1) from the door seal channel below the arrows indicated on either side of (1) in ([Fig. 2](#)).

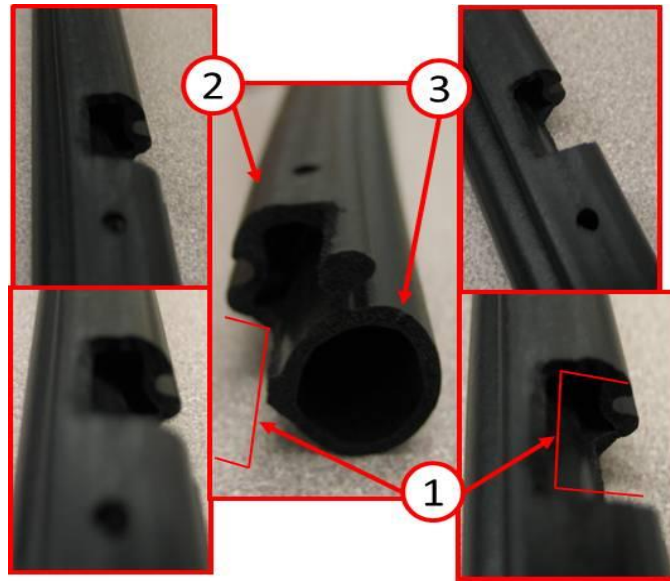
Fig. 3 Seal Modification Desired Result

- 1 - Seal Notch (Area to be Removed)
- 2 - Outer Door Side of Seal ("Wet Side")
- 3 - Inner Door Side of Seal/Bulb ("Dry/Body Side")

NOTE: Be careful when notching the door seal so that the inside wall of the bulb seal (3) is not cut when the notch (1) is cut into the outer “wet side” (2) of the door seal. ([Fig. 3](#)) shows the desired result of the door seal notch procedure outlined in [Step #3](#) with relation to the structure of the seal and the layout of the notch on the seal relative to the door.

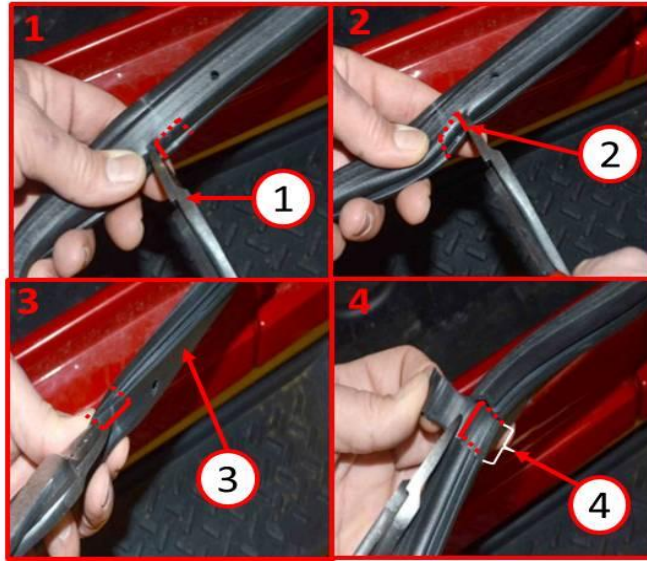
Fig. 4 Seal Modification

- 1 - Door Seal Notch Mark (Center of Notch)
- 2 - Diagonal Cutters
- 3 - Door Seal Notch
- 4 - Door Seal
- 5 - Seal Notch Width (5/8"/16mm)

-
3. Locate the mark (1) made in [Step #1](#) on the door seal, below the lower door panel fastener, and designate it as the center of the notch (3) which should be approximately 5/8" (16mm) wide (4) ([Fig. 4](#)).
 4. Using diagonal cutters, (2) cut approximately 1/4" (6mm) into the outer door/"wet side" of the seal on either side of the seal center mark (1) outlined in top pictures 1 & 2 of ([Fig. 4](#)).
 5. Connect the two cuts from [Step #4](#) by cutting along the bottom side/door bulb side of the seal as outlined in picture 3 of ([Fig. 4](#))
 6. Connect the two cuts from [Step #4](#) by cutting along the top side/door channel "flat side" of the seal as outlined in picture 4 of ([Fig. 4](#))

NOTE: Use caution not to cut into the bulb seal portion of the seal while performing the notch procedure.

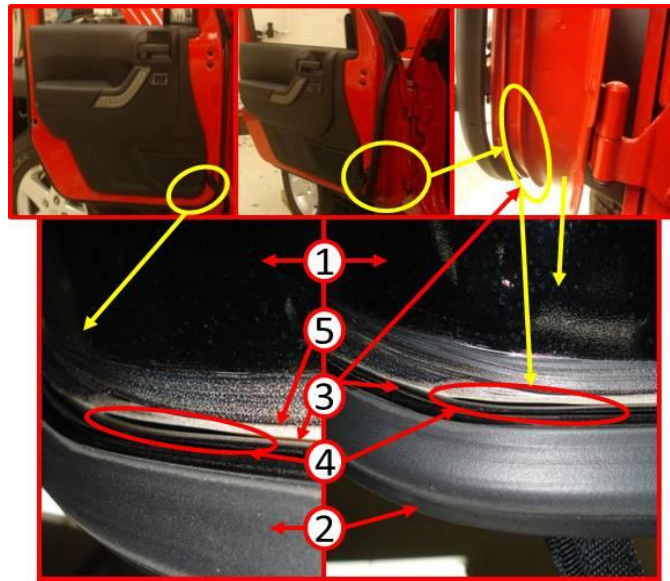
Fig. 5 Sealer Skip Inspection

-
- 7. Inspect the sealer (5) applied along the inboard lower edge of the door seal channel (3).
 - 8. Were any sealer skips present?
 - a. Yes >>> Proceed to [Step #9](#).
 - b. No >>> Proceed to [Step #10](#).
 - 9. Seal any skips (4) where there may be a void between the door seal channel (3) and the bottom of the door (1) with Kent Hi-Tech clear seam sealer.

- 1 - Door (Bottom Side)
- 2 - Door Seal (Bottom of Door)
- 3 - Door Seal Channel
- 4 - Seam Sealer Skip
- 5 - Seam Sealer (Correctly Applied)

NOTE: Follow the manufacturer's recommendations for surface preparation and curing times.

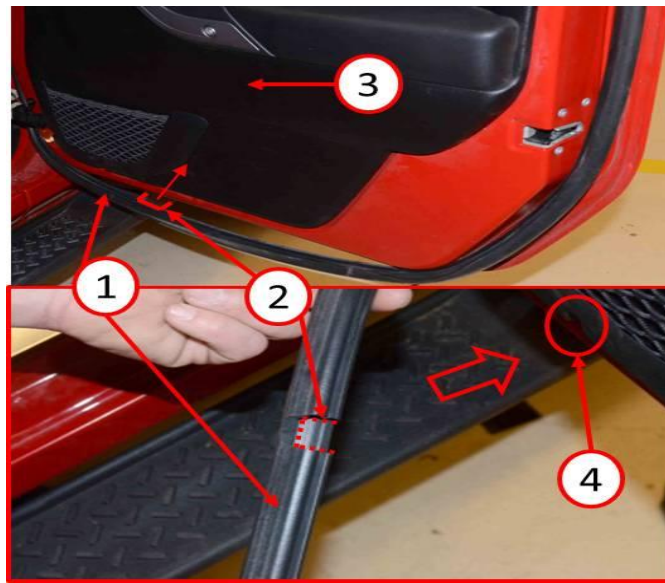
Fig. 6 Reinstall Door Seal

- 1 - Door Seal
- 2 - Door Seal Notch
- 3 - Door Panel
- 4 - Door Panel Lower Fastener (Notch Location)

10. Reinstall the lower section of the door seal (1) back into the lower door seal channel so that the door seal notch (2) faces outward toward the “wet side” of the vehicle.

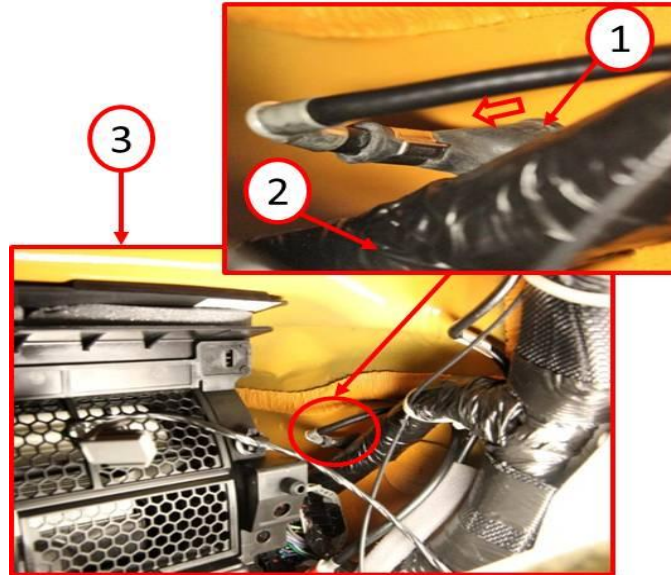
Fig. 7 Antenna Grommet Inspection

- 1 - Antenna Grommet
- 2 - Main Wire Harness
- 3 - Glove Box Opening View (Glove Box removed)

11. Was water still entering the vehicle onto the front floor?
 - a. Yes >>> Proceed to the next step.
 - b. No >>> Return the vehicle to the customer.
12. Was water dripping down the cowl-side inner body panel under the Instrument panel or dripping down the front of the door seal from the A-pillar area?
 - a. Cowl-side inner body panel >>> Proceed to [Step #13](#).
 - b. Door Seal from A-pillar area >>> Proceed to [Step #16](#).
13. Remove the passenger side front speaker. Refer to the detailed procedures available in DealerConnect>TechCONNECT> under: Service Info> 08-Electrical> SPEAKER> Removal> Instrument Panel - Passenger Side
14. Through the glove box opening (3) with the passenger side speaker and glove box removed verify that the antenna grommet (1) is properly seated to the inner body side ([Fig. 7](#)).

NOTE: The antenna grommet is a pull to seat type of grommet. If the grommet is not pulled through the cowl-side inner body panel enough to be properly seated, it must be pulled gently toward the vehicle interior in order to seat it. If the grommet has been over-pulled through the cowl-side inner panel, push it outboard and seat it properly. Make sure that the main wire harness (2) is not pushing on the antenna grommet causing it to be pushed out of the inner body side panel.

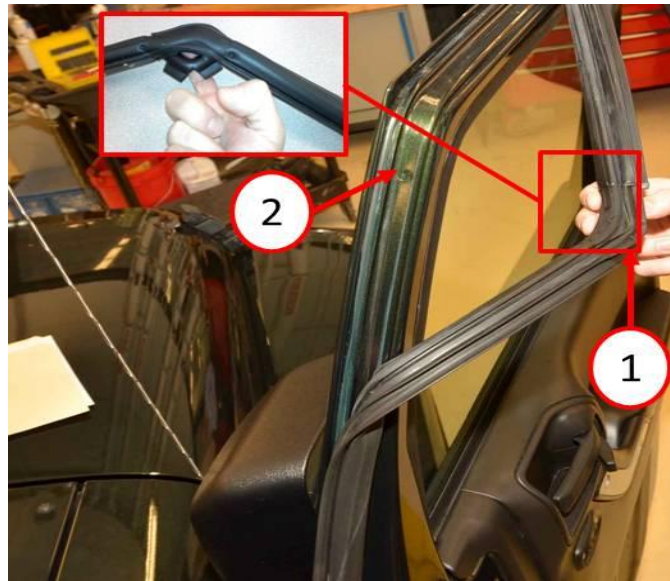
Fig. 10 Door Weatherstrip Removal

NOTE: Inspect the side upper door seal channel (2) for possible sealer skips

- 1 - Door Weatherstrip
- 2 - Metal Weatherstrip Channel

17. Remove the suspect door upper weatherstrip seal (1) at the A pillar upper corner, from metal channel (2) enough to gain access to stuffer access slot ([Fig. 10](#)).

19. Seal any skips where there may be a void between the door seal channel and the top of the door with Kent Hi-Tech clear seam sealer.

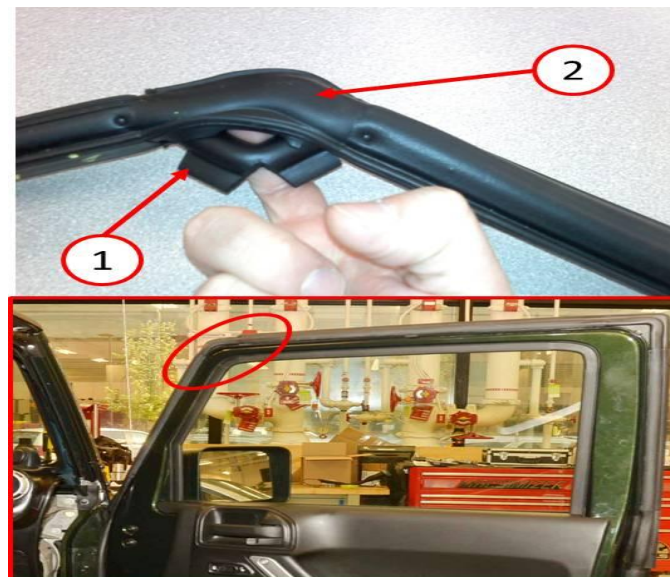
Fig. 11 Door Stuffer Access

- 1 - Door Stuffer
 - 2 - Door Weatherstrip
-

20. Pull out half of the existing stuffer that goes down the front A-pillar side of the door weatherstrip through the access slot in the backside of the weatherstrip (Fig. 11).

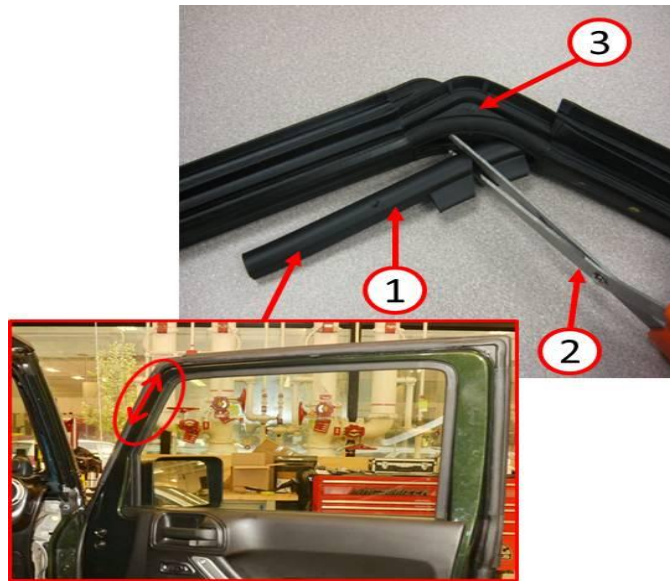
Fig. 12 Door Stuffer Removal

- 1 - Stuffer
- 2 - Scissors
- 3 - Door Weatherstrip

21. Remove half the existing stuffer (1) by cutting at the stuffer relief joint using scissors (Fig. 12).

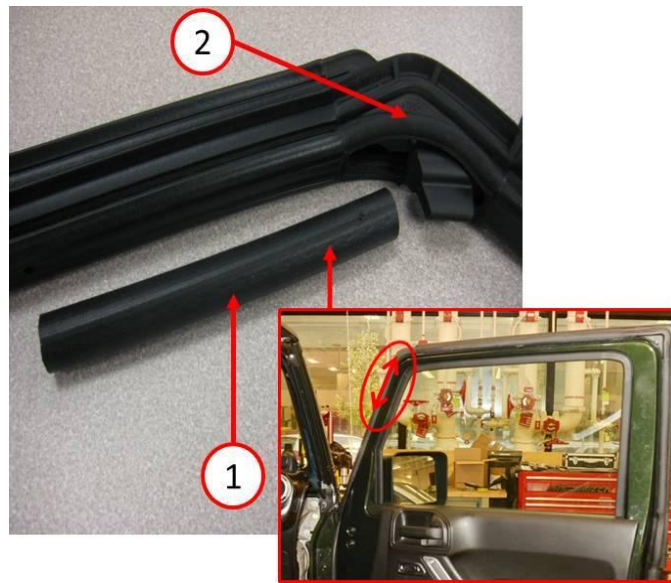
Fig. 13 Install New Door Stuffer

- 1 - New Stuffer
- 2 - Weatherstrip

-
22. Insert the new stuffer (1) into the weather strip where existing was removed (Fig. 13).

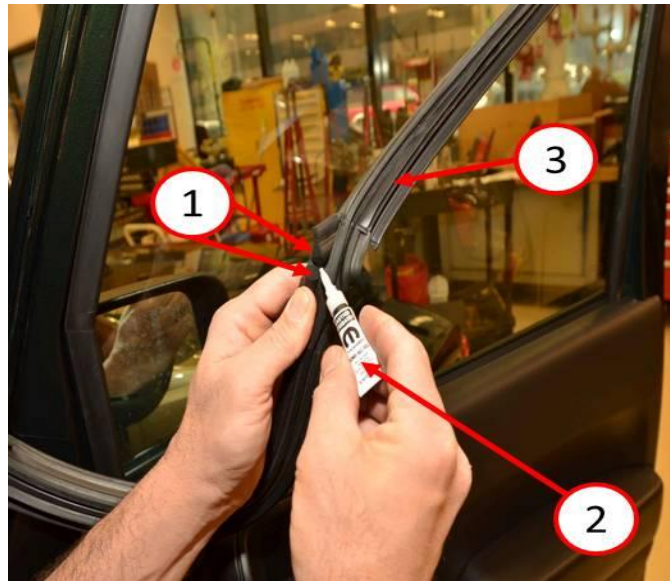
Fig. 14 Door Stuffer Installation

- 1 - Stuffers
- 2 - Mopar Bond All Gel
- 3 - Weatherstrip

- 23. Clean stuffer sections to be bonded with isopropyl alcohol and allow it to flash.
- 24. Bond both stuffers at the intersection (1) with Mopar Bond All Gel (2) and make sure there is no gap between stuffers as shown in (Fig. 14).

NOTE: The glue is being used to keep the new a-pillar stuffer in position and to prevent it from moving down the weatherstrip over time.

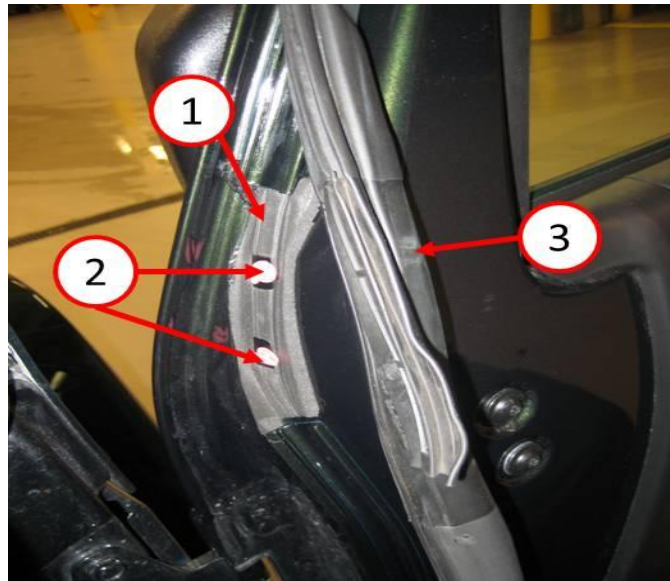
Fig. 15 Foam Removal

- 1 - Foam Patch (right side shown)
- 2 - Weatherstrip Retaining Clips
- 3 - Weatherstrip

25. Remove existing foam patch (1) and clean door surface with isopropyl alcohol ([Fig. 15](#)).

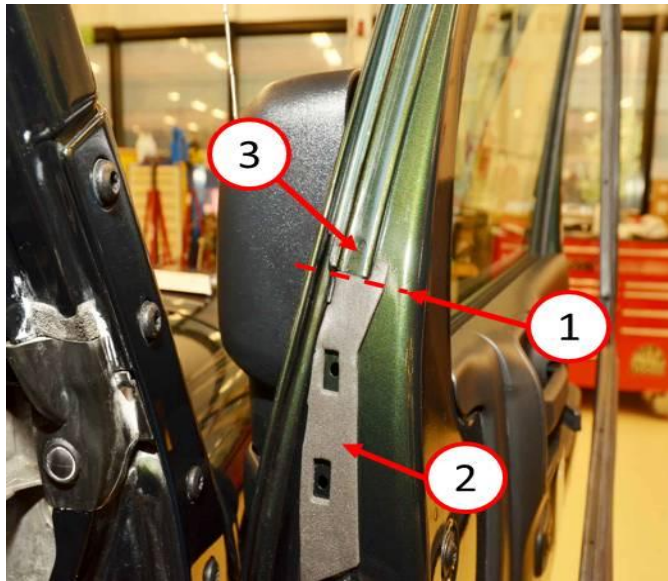
Fig. 16 Foam Installation

- 1 - Edge of Door Weatherstrip Channel
- 2 - Foam (right side shown)
- 3 - Upper Door Seal Channel

26. Wipe door surface with adhesion promoter and once flashed insert the new foam patch (Fig. 16).

NOTE: Ensure foam patch is tight against upper door weatherstrip channel by beginning installation at the top of foam and finishing at the bottom. Make sure foam gasket is applied flat against the door with no creases or wrinkles.

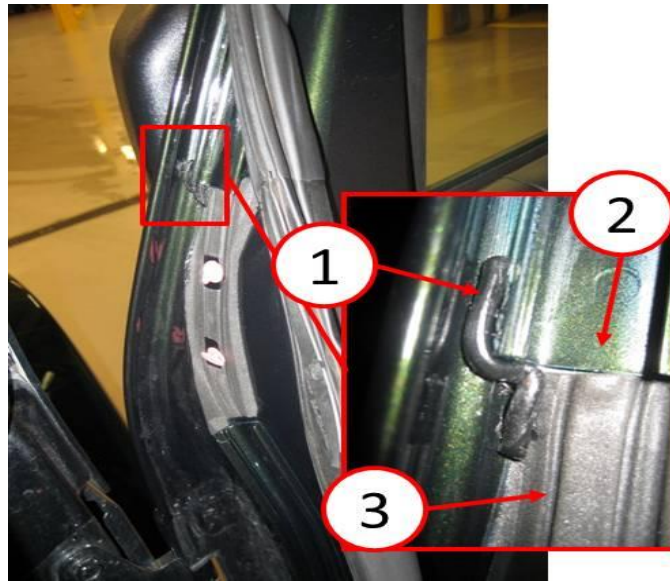
Fig. 17 Butyl Tape Installation

- 1 - Butyl Tape
- 2 - Door Seal Channel
- 3 - Foam Patch (right side shown)

27. Install approximately 1 inch of butyl tape to upper door weatherstrip channel as shown (Fig. 17).

NOTE: Press butyl down with fingers to seal against the sides and bottom of the channel and along edge of foam.
