# Service Bulletin

**Subject:** Squeak Noise from Rear of Vehicle (Lubricate Rear Leaf Springs)

**Models:** 1999-2007 Chevrolet Silverado (Classic)  
2007-2012 Chevrolet Colorado  
2007-2013 Chevrolet Silverado  
1999-2007 GMC Sierra (Classic)  
2007-2012 GMC Canyon  
2007-2013 GMC Sierra  
2007-2010 HUMMER H3, H3T

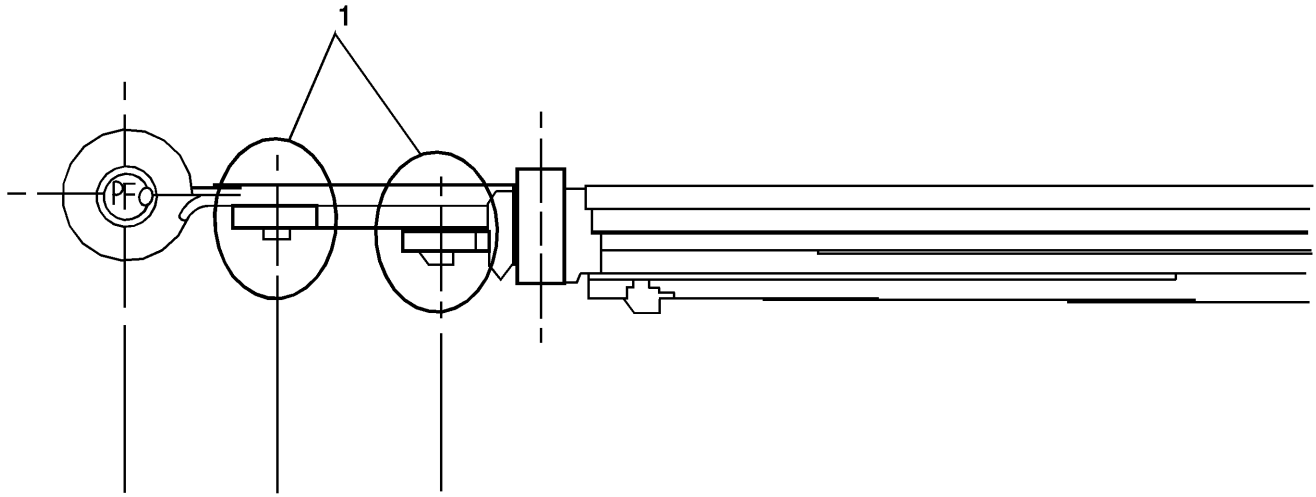
Some customers may comment about a squeak noise coming from the rear of the vehicle. During normal operation, certain vehicles may exhibit a squeaking noise that may be traced to the rear leaf springs. While this noise is an operating characteristic of leaf springs, the frequency and severity of this noise will be affected by the roads that the vehicle is driven on.

This condition may be due to debris getting between the leaf springs.

**Note:** Ensure any tool used to gently pry the tip inserts or spring leaves is protected to prevent damage to the spring leaves.

5. Apply a liberal amount of grease, P/N♦12345996 (in Canada, use P/N♦10953501), both underneath and on top of the front and rear tip inserts for the #2 and #3 leaves, as indicated below. A screwdriver can be used to gently pry up the tip insert; however, a rag around the screwdriver must be used to prevent damage to the spring. Use a flat-bladed tool, such as a gasket scraper to properly distribute the grease.
6. Lower the vehicle to the ground and test drive to verify the repair.
