Service Bulletin

Subject: Repair Information for Reconnection of Rear Window (Defogger) Contact or Tab

Models: 2000-2014 GM Passenger Cars and Trucks
2007-2010 Opel GT
2007-2008 Daewoo G2X
Equipped With Electric Rear Window Defroster (RPO C49)

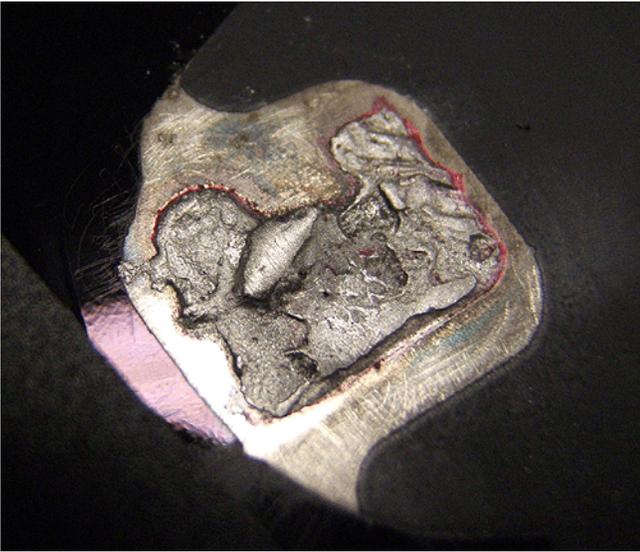
3. Prepare the surface of the used defroster tab (not required for new tabs on new-style full-size utility models) and the defroster buss bar with fine grain (500 grit) sandpaper or Emery cloth. It is not necessary to remove all of the original solder, but it should be scuffed sufficiently so that no oxidation is present. The photo above shows a close up of a properly prepared surface.

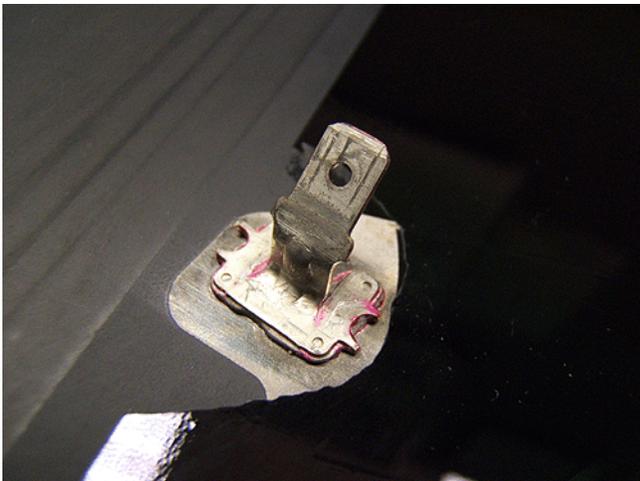
6. The above illustrates an ideal finished solder joint. Additional stray solder will not harm the performance of the bond; however, while it is unlikely that customers may refer to the appearance of the rear window defroster and its components as a positive styling feature of the vehicle interior, it is easy to elicit the opposite reaction due to a poor cosmetic application.
