Bulletin No.: PI0718B

Service Bulletin

Subject: Audio System Speaker Rattle, Buzz Noise, Poor Sound When Playing Radio or Other Music Source

Models: 2007-2013 Cadillac Escalade EXT

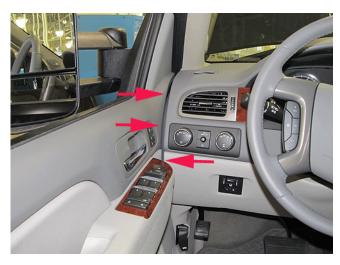
Loose Trim, Panel to Panel Contact

An interface may cause a rattle or buzz (for example, between a door and instrument panel).

- To better identify the location, open the door and determine if the buzz or rattle follows the door. This may be caused by loose door trim or water deflector contact with the trim. Refer to **Door Trim/Water Deflector Rattle** below.
- Determine if a rattle is heard between the instrument panel and door. This may be caused by contact between the instrument panel and the door trim when the door is closed. If the noise goes away when the door is opened, inspect the trim panel on the door to ensure it is in the correct position. Also, inspect the snap-on trim panels on the instrument panel ends to ensure they are fully engaged into the instrument panel.
- If the rattle or buzz is determined to be coming from the instrument panel, inspect for loose panels, screw covers or contact between trim panels such as an A pillar to instrument panel interference.

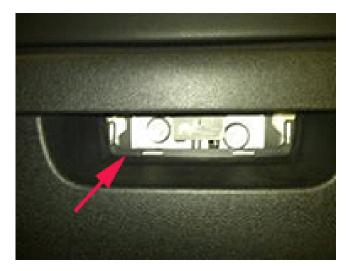
Door Trim/Water Deflector Rattle

If the rattle is heard within the door trim, depress the trim with your hand. If the sound changes or the rattle/buzz decreases when pressure is applied, follow the steps below.

- Remove the door trim screw cover behind the door handle on the affected door and apply pressure to the water shield. If this cures the condition, refer to the water shield procedure below.
- Once the door trim is removed, confirm the perimeter clips are not damaged, bent or missing. Replace damaged door clips. Add flocking tape as needed.

• If the rattle is caused by the water shield, install two 100 mm (4 in) long layers of 1" x 9/16" adhesive backed foam shim stock such as *Kent Industries Part # P46515 or the equivalent, to compress the water shield as shown. Confirm any added foam does not interfere with the window or door lock operation.
