Service Bulletin

PRELIMINARY INFORMATION

Subject: DTC C027B, Low Brake Pedal Feel After Master Cylinder Repairs

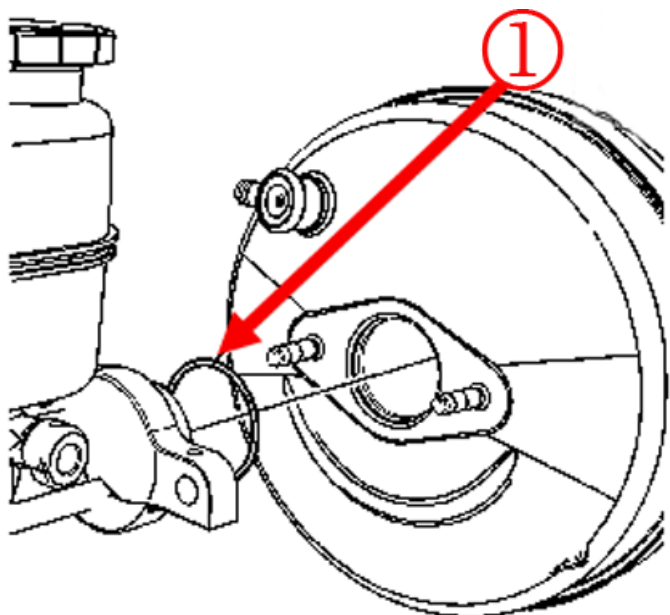
Some customers may comment on a low brake pedal during brake pedal apply. During diagnosis, a DTC C027B may be found stored in the EBCM. This concern may have started after the master cylinder was unbolted from the brake booster for any reason.

This may be caused by a small vacuum leak between the master cylinder and the brake booster. There is an O-ring between the master cylinder and the brake booster that may have fallen off during the prior repairs.

Inspect for the O-ring (1) between the master cylinder and the brake booster before performing any other diagnostics for the low brake pedal or the DTC C027B. Replace the O-ring if missing or damaged.

Tip: Exhaust the booster vacuum by either pumping the brake pedal or pulling the check valve out prior to removing the master cylinder. The suction may be helping to dislodge the O-ring when pulling the master cylinder out.
