Service Bulletin

Subject: Poor Engine Performance and/or DTCs Set After Partial Engine Replacement

Models: 2011-2014 Chevrolet Cruze
2012-2014 Chevrolet Sonic
Equipped with Engine RPO LUW

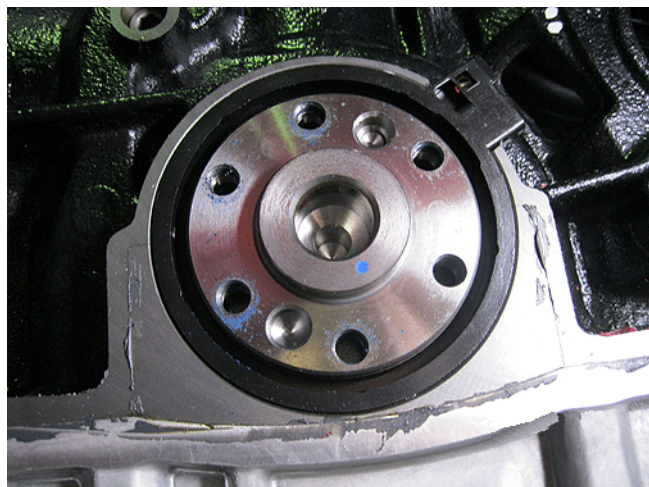
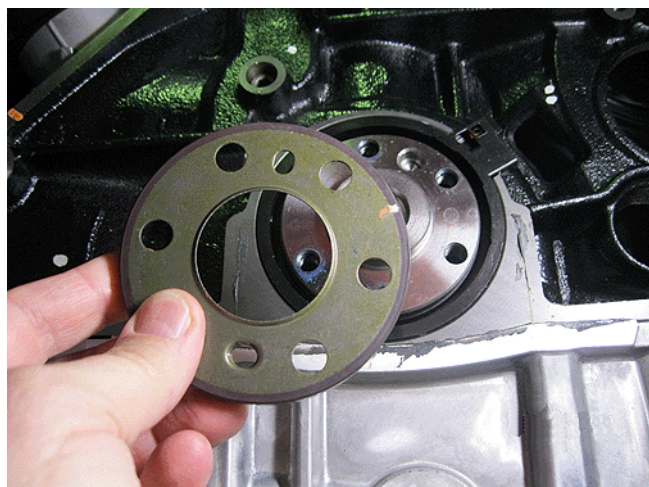
Most components that need to be transferred are very obvious. One part that is not obvious is the crankshaft reluctor wheel. This needs to be transferred from the old engine and installed onto the new engine.

The reluctor wheel is located between the flywheel and the crankshaft. Once the flywheel is removed, the reluctor wheel can be transferred to the rear of the

Failure to transfer this part will cause the engine to run poorly and set DTCs.

new engine and the flywheel can be installed to retain the reluctor.
