# Service Bulletin

**Subject:** Remove Flocked Material from Front Side Door Interior Trim Panel During PDI

**Models:** 2013-2014 Buick Enclave

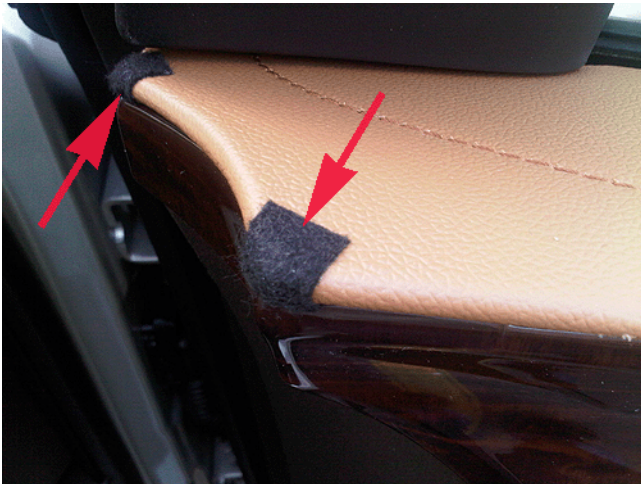
Two pieces of adhesive backed flocking material (black felt) are installed on the front side door interior trim panels as shown. This material is installed to protect the door panels during the build process.

Remove the flocking material from both front side door interior trim panels during the Pre Delivery Inspection (PDI).

Clean any adhesive residue from the trim panel. Use care to not damage the finish. For information on proper interior cleaning products, refer to the latest version of Bulletin Number 06-00-89-029.
