## General Information

Kysor fan clutches are being returned for failed bearings and excessive runout when the runout is actually within tolerance. This results in a "no defect found" (NDF) evaluation on the part, and a charge-back to the dealer. To help prevent this issue, carefully inspect fan clutches following the procedure below.

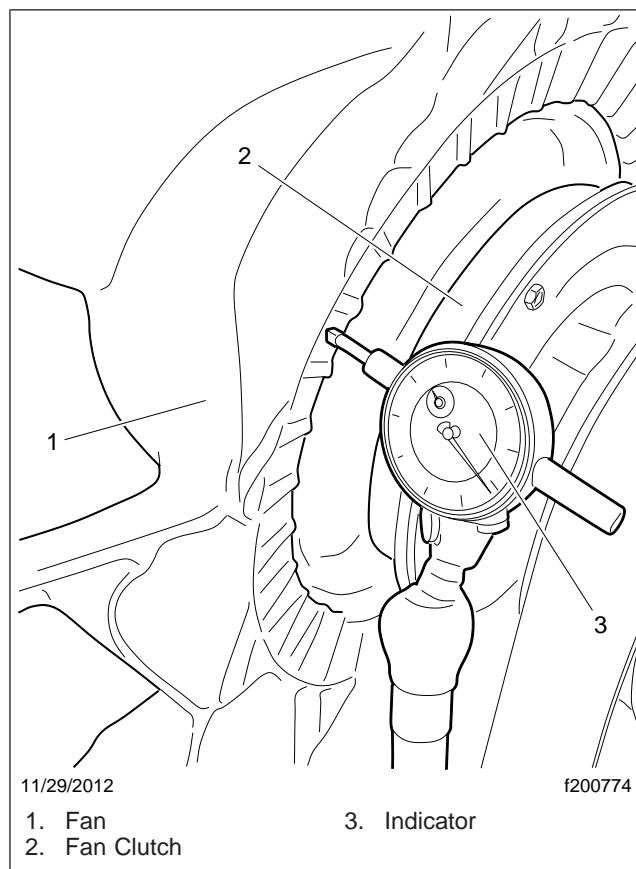
**Fig. 1, Positioning the Indicator**

1. Park the vehicle on a level surface, shut down the engine, and set parking brake. Chock the tires.
2. Position the indicator on a flat surface near the outside diameter (OD) of the clutch hub section of the fan as shown in **Fig. 1**.
