February 2013  
FL631AB  
NHTSA #12V-405  
Transport Canada #12-281  
REVISED NOTICE

## Subject: Perpendicular Aluminum Air Tank Mounting Brackets

**Models Affected: Specific Freightliner 114SD, Business Class M2, Cascadia, and Coronado vehicles; Sterling 9500 vehicles; and Western Star 4700 vehicles manufactured July 29, 2008, through December 15, 2011.**

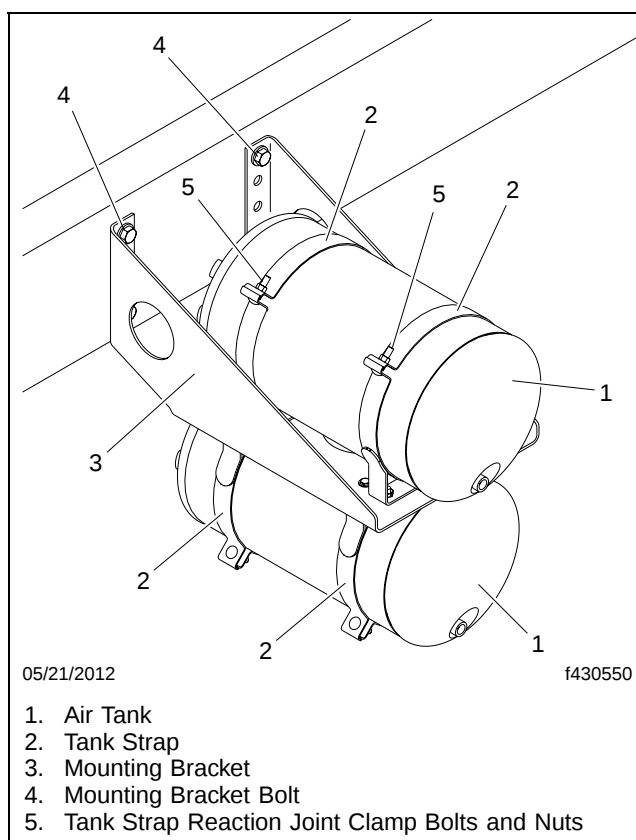
**Fig. 1, Perpendicular Air Tank Installation**

Certain perpendicular air tank mounting brackets may develop cracks under some conditions. Increasing size of the cracks may lead to air tank brackets separating from the frame rails which may lead to a loss of air in the air brake system, possibly leading to increased stopping distances. Air tanks that become separated from a moving vehicle may create a road debris hazard, increasing the risk of a crash.

1. Park the vehicle on a level surface, shut down the engine, and set the parking brake. Securely chock the tires.
2. Locate the appropriate 14-3/8" wide air tank bracket(s) to be replaced.
3. Drain the air from the air tanks.
4. Mark or tag all tank air lines, couplers, and valves for later assembly, then disconnect the components. Cap the exposed ports tightly to keep out contaminants.
5. Remove each air tank, as follows.
  - 5.1 Loosen the reaction joint clamp bolts.

- 7.4 Raise the corner of the battery box to access the bracket fasteners.
8. Remove the aluminum air-tank mounting bracket from the frame rail.
9. Install the new steel air-tank mounting bracket on the frame rail. Tighten the mounting bolts and nuts 120 to 150 lbf-ft (163 to 203 N·m).

10. Lower the battery box, and install the fasteners. Tighten 120 to 150 lbf-ft (163 to 203 N·m).
11. Install the batteries and the battery box cover.
12. Remove the air tank cradles from the aluminum air tank mounting bracket and install them on the new steel bracket. Tighten the mounting bolts and nuts 25 to 31 lbf-ft (34 to 42 N·m).
