Coronado  
Business Class M2  
> Cascadia  
108SD/114SD

**Freightliner  
Service Bulletin**

**Description of Revisions:** *This bulletin replaces the version dated April 2013. The title is changed and a reference to transmission solenoid failure has been added.*

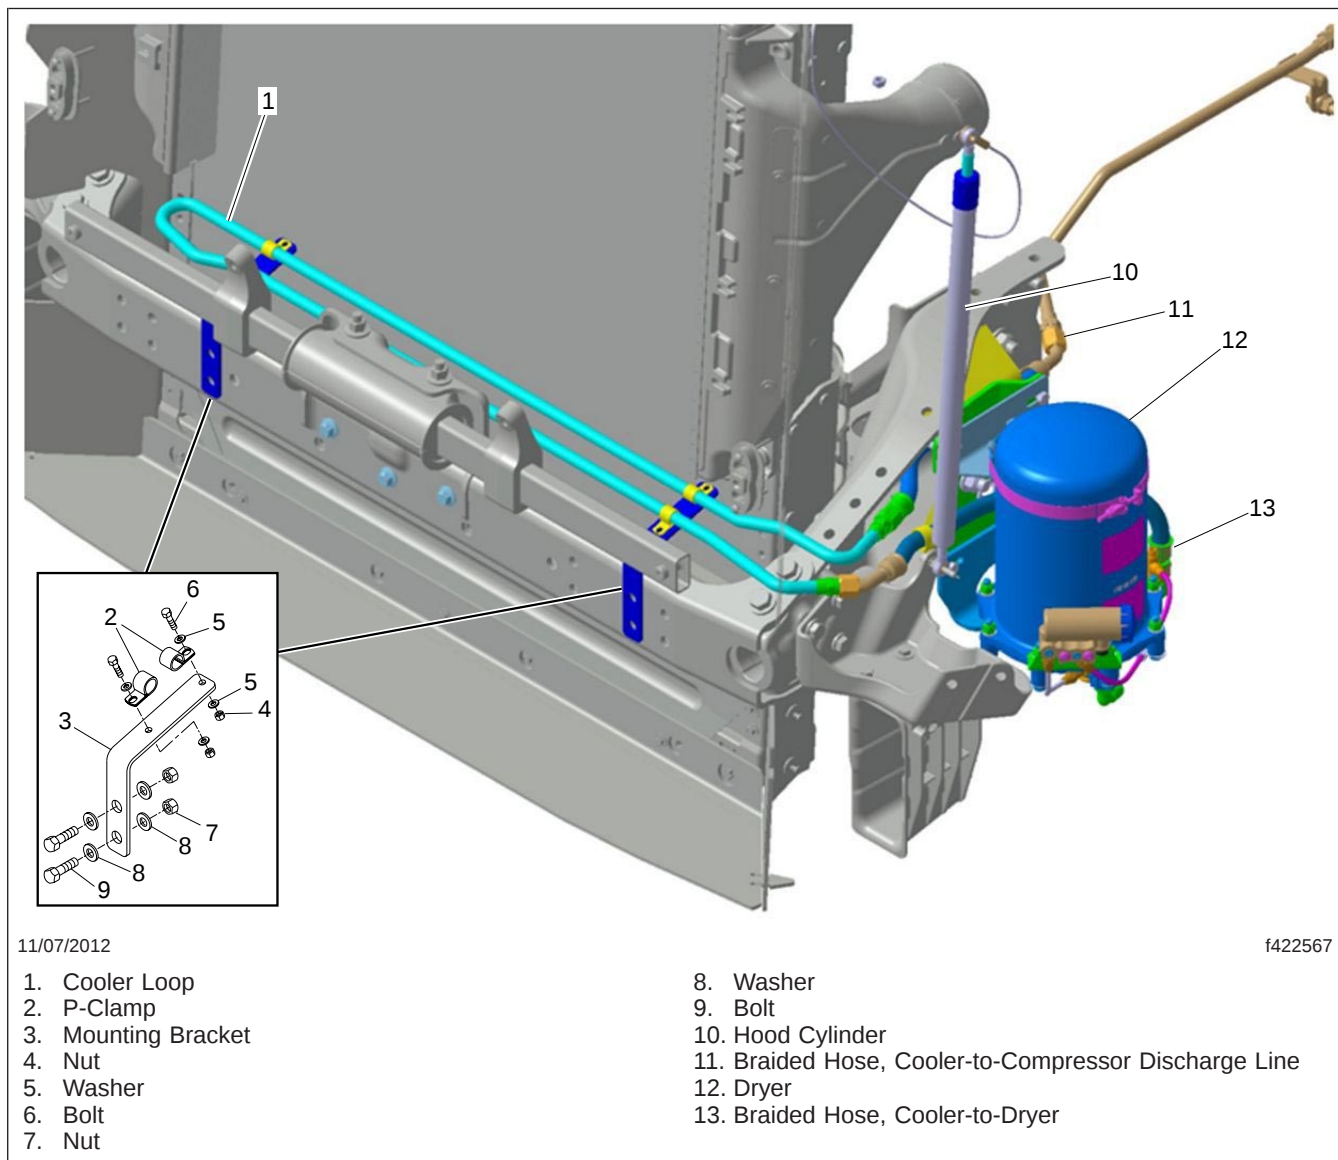
**Fig. 1, Cooler Loop Installation (AD-9/AD-IP dryer shown)**

If the issue persists, the air dryer inlet air temperature may be excessive, resulting in reduced dryer performance. Install an in-line air cooler loop, or a longer air line, depending on the vehicle configuration.

1. Park the vehicle on a level surface, shut down the engine, and set the parking brakes. Chock the wheels securely.
2. Disconnect the batteries at the negative post.
3. Drain the air from the air system.
4. Remove the grille. See [Section 88.00, Subject 110](#) of the *Cascadia Workshop Manual*.
5. Open the hood.
6. Remove the bumper. See [Group 31](#) of the *Cascadia Workshop Manual*.
7. Relocate the air temperature sensor on the right side of the frame closing crossmember down one hole.
8. Remove the rock screen from the lower face of the radiator.
9. Install the cooler-loop mounting brackets. See [Fig. 1](#).
10. Position the P-clamps on the cooler loop and install the cooler loop on the brackets. Do not tighten the P-clamp fasteners at this time. See [Fig. 1](#).
