Century Class Conventional  
> Argosy COE  
Cargo  
Columbia

**Freightliner  
Service Bulletin**

## General Information

## Cab Water-Leak Detection

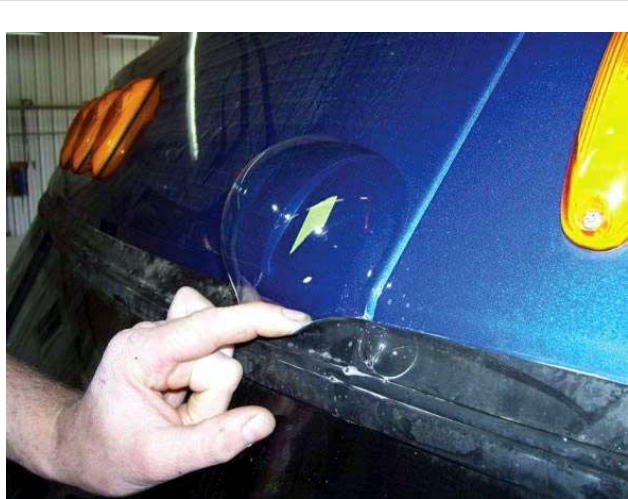
f670148

NOTE: Cascadia shown; an Argosy cab leak produces a similar result.

**Fig. 1, Likely Leak Between Windshield Seal and Cab**

Repair leaks in the windshield seal using the approved method and adhesive. Refer to the *Century Class Trucks Workshop Manual*, **Section 60.00** for instructions on windshield seal repair.

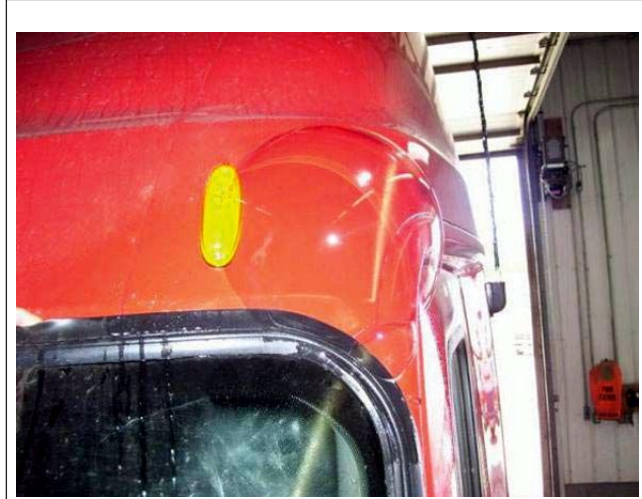
f670149

Cab/roof seam (coach joint) leaks are often misdiagnosed as sun-visor mount or marker light leaks because they result in water accumulation in the header, and possibly water dripping onto the dash from above. If a sun-visor mount leak or a marker light leak is present, the soapy water method of leak testing described in this bulletin should clearly indicate the location of the leak.

NOTE: Cascadia shown; an Argosy cab leak produces a similar result.

**Fig. 2, Likely Leak Between Roof Cap and Cab**

1. Working on one side of the vehicle at a time, remove the fasteners that attach the side sun visor and visor bracket assembly to the cab. By removing the side sun visor and the aft bracket, the cab/roof seam (coach joint) above the door can be easily accessed.
2. Remove the side visor and the rear side bracket.
3. Clean the seam area with air from a shop air hose, and dry it with a clean shop rag.
4. Apply masking tape to the edges of the roof and cab-side seams from the edge of the front visor bracket (just above the A-pillar) to a point in the seam beyond the B-pillar on the sleeper. Also, apply tape to both sides of the vertical section of the seam just above the rear of the door opening. See [Fig. 4](#).
5. Apply a bead of silicone, part number 48-00094-501, using a caulking gun, to the horizontal and vertical sections of the seam. See [Fig. 5](#). Fill in the seam completely.

6. Smooth the silicone by running a wetted finger over the bead.
7. Carefully remove the masking tape from the surface of the cab, taking care not to disturb the silicone.
8. Install the side visor bracket on the vehicle.
9. Install the side sun visor.
10. Repeat these steps on the other side of the vehicle, if needed.

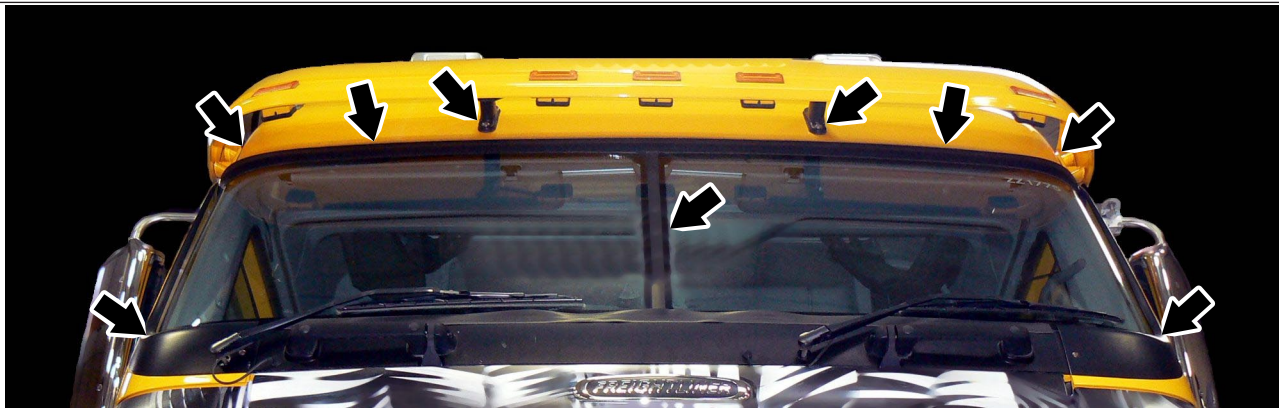
f670150

6. Spray the cab and sleeper (if so equipped), with the wash solution, and look for bubbles. See [Fig. 1](#) and [Fig. 2](#) for examples of likely leaks. Inspect all applicable areas shown in [Fig. 3](#) and listed below:
  - windshield center post
  - windshield seal perimeter (especially the upper and lower outboard corners)
  - front wall to A-pillar interface
  - exterior sun-visor mounts
  - marker lights (if mounted on roof)
  - roof deflector mounts (if so equipped)
  - cab/roof seam (coach joint)
  - sleeper roof side windows (if present)
7. Mark areas of suspected leaks.

**Fig. 3, Areas to Inspect for Leaks**

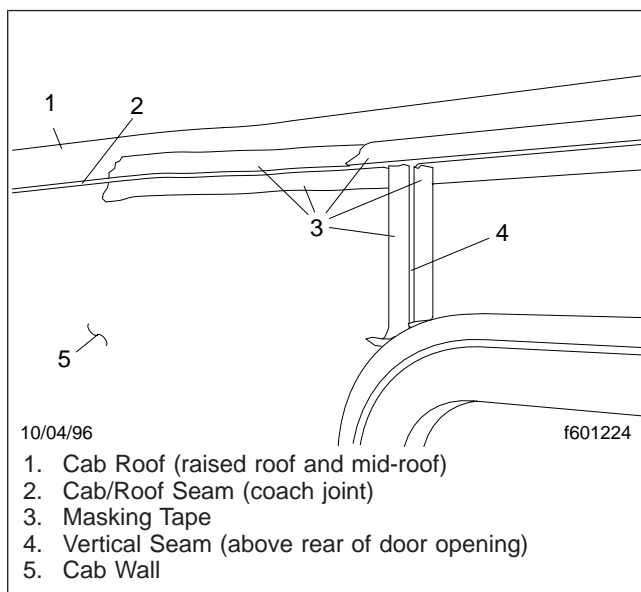
**Fig. 4, Cab Seams Prepared for Caulking**

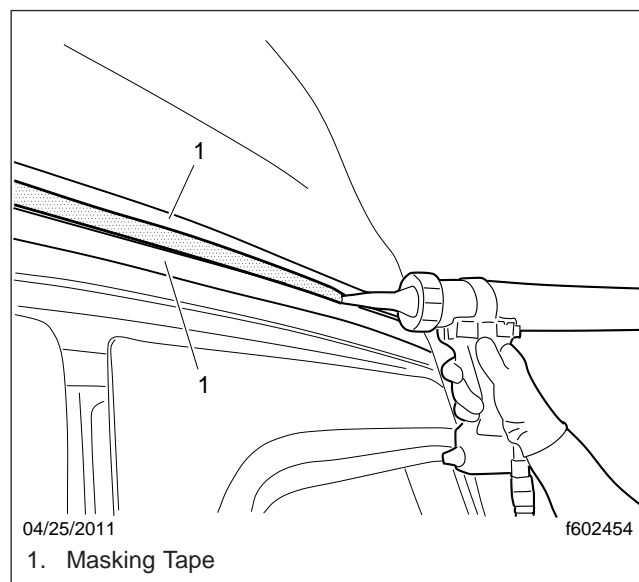
**Fig. 5, Applying Caulking to Seam**

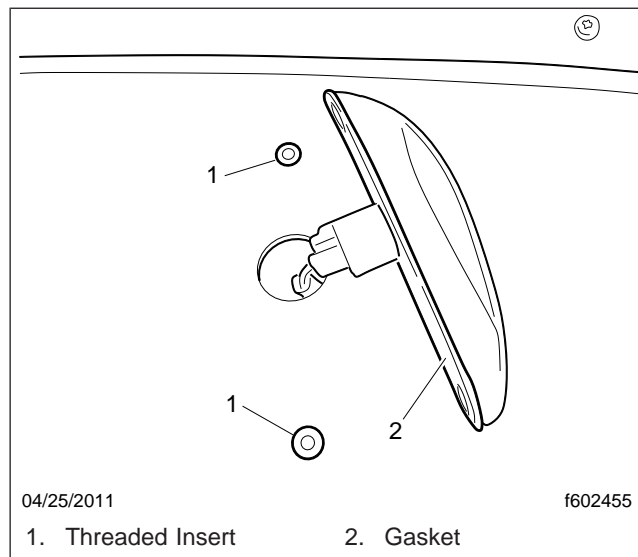
**Fig. 6, Marker Light (shown detached from cab roof)**

**NOTE:** The threaded inserts in the cab have sealed ends, and are a highly unlikely source of leakage. If a leak is found at a sun-visor mount or marker light, it is much more likely to be from the electrical connector hole in the roof cap.

2. Make sure that the sun-visor mount or marker light gasket is in good condition and correctly installed. Replace any damaged gaskets. See **Fig. 6**.

If the leak was at a marker light, install the marker light. Do not under- or over-tighten the screws.
