Freightliner
Service Bulletin

Description of Revisions: *This bulletin replaces the version dated December 2012. The list of symptoms and troubleshooting diagnostics have been revised.*

Cascadia vehicles equipped with Eaton manual transmissions may experience no-start faults that are associated with the clutch position combination switch (clutch control switch). Recent investigations have exposed two possible causes, and this bulletin should be used to determine the cause of the problem. Use the procedure in this bulletin, and service information published on www.AccessFreightliner.com and www.RoadRanger.com, to diagnose and repair the problem, if the following symptoms are present:

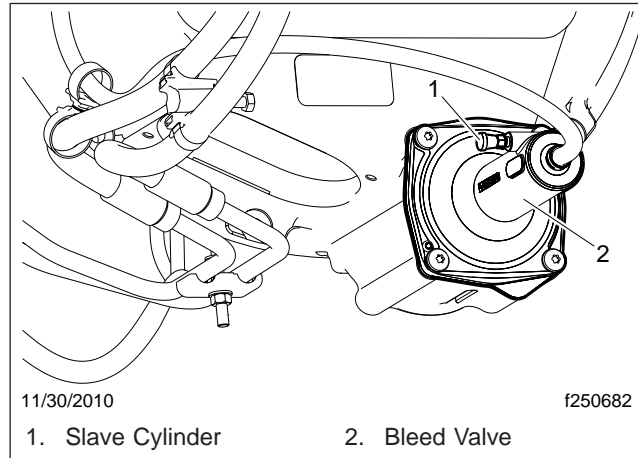
Fig. 4, Slave Cylinder Bleed Valve

5. Continue to monitor the SAM Cab ECU while having an assistant open the bleed valve on the slave cylinder (see Fig. 4), allowing the pedal to travel all the way to the floor. Have the assistant close the valve. Does the actuation of the pedal switch register on the "Bottom of Clutch Circuit" indicator? If necessary, top off fluid with DOT 4 brake fluid.

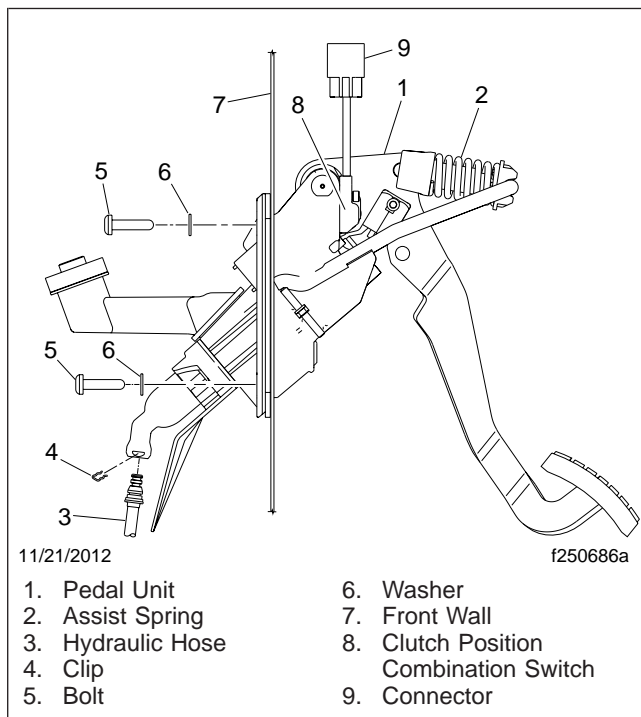
Fig. 5, Clutch Pedal Assembly

6. Disconnect the chassis harness from the clutch position combination switch. See Fig. 5.
7. Use a jumper wire to close the clutch low position control circuit on the chassis side (between pins A and C in Table 1), and look for a response on the SAM Cab ECU template. Does the response register on the template?

If YES, replace the switch with the newer version that is marked with a yellow dot, indicating the seal has been removed. See Cascadia Workshop Manual, Section 25.01, Subject 150.

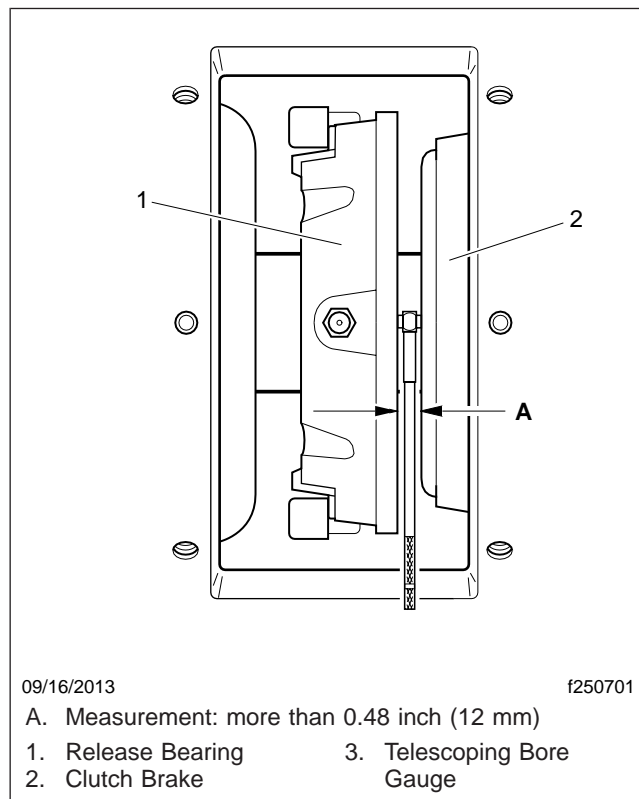
Fig. 6, Clutch Gap

8. Remove the clutch inspection cover.
9. Using a telescoping bore gauge, measure the gap between the clutch brake and the release bearing, then measure the gauge with a digital caliper. The distance should be more than 0.48 inch (12 mm). See [Fig. 6](#).

If the distance is correct, install the inspection cover. Tighten the screws 14 to 18 lbf-ft (19 to 24 N·m). Replace the hydraulic pedal assembly. See *Cascadia Workshop Manual*, **Section 25.01**.

If the distance is less than 0.48 inch (12 mm), reset the clutch (see “Resetting the Clutch”).

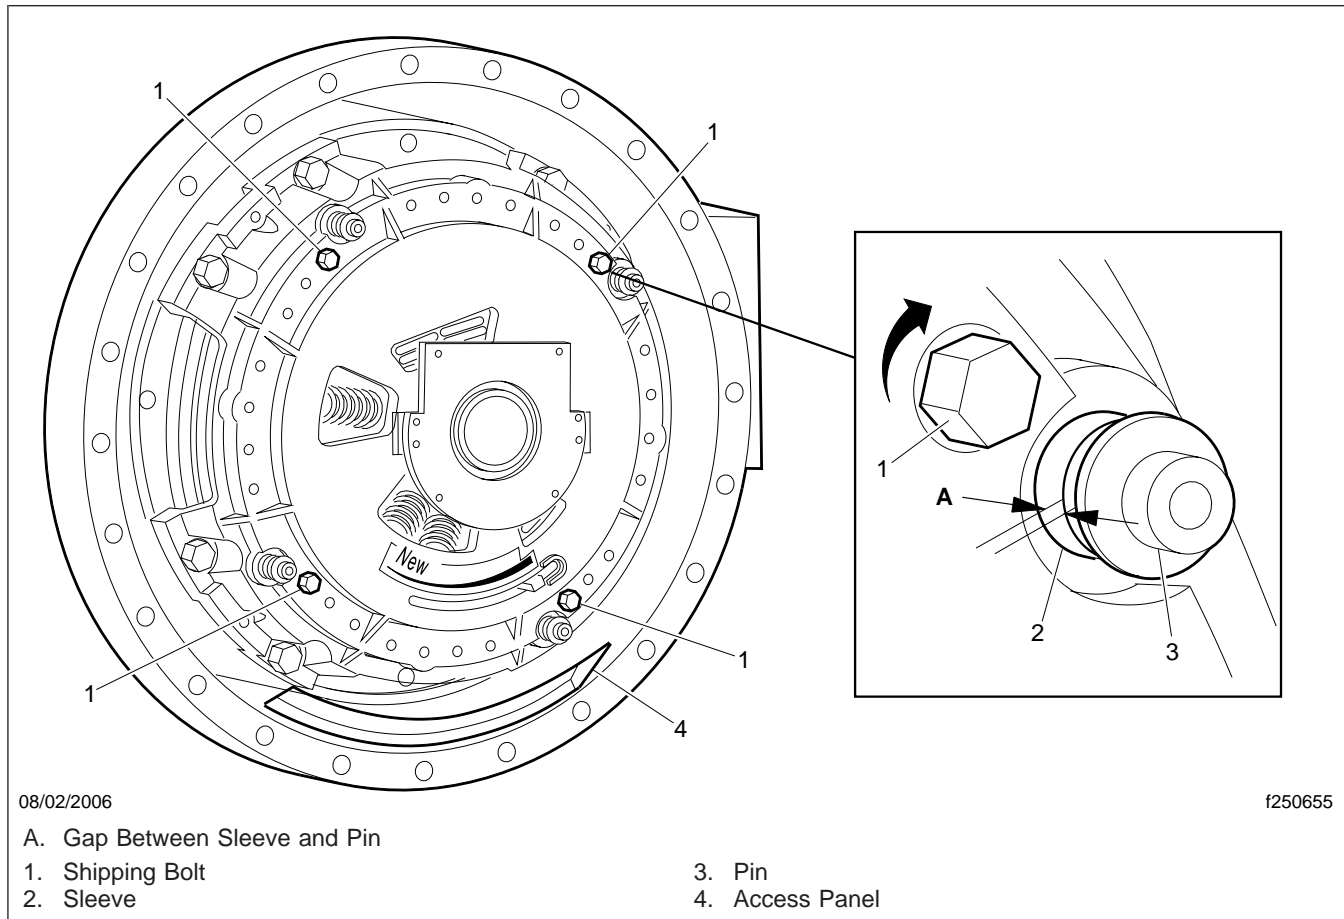
Fig. 8, Removing the Gap Between Sleeve and Pin

IMPORTANT: To prevent the clutch from returning to an over-adjusted position, the gaps between the sleeves and pins have to be eliminated, as detailed below.

5. Install four shipping bolts (7/16-14 x 1-3/4 UNC) next to the sleeves and pins, as shown in **Fig. 8**. Tighten the bolts so that the gaps between the sleeves and pins are eliminated.
