# FIELD SERVICE CAMPAIGN

Subject: **Field Service Campaign 13M2**  
**EPA07/10 DD Engine EGR Delta Pressure Sensor Replacement**

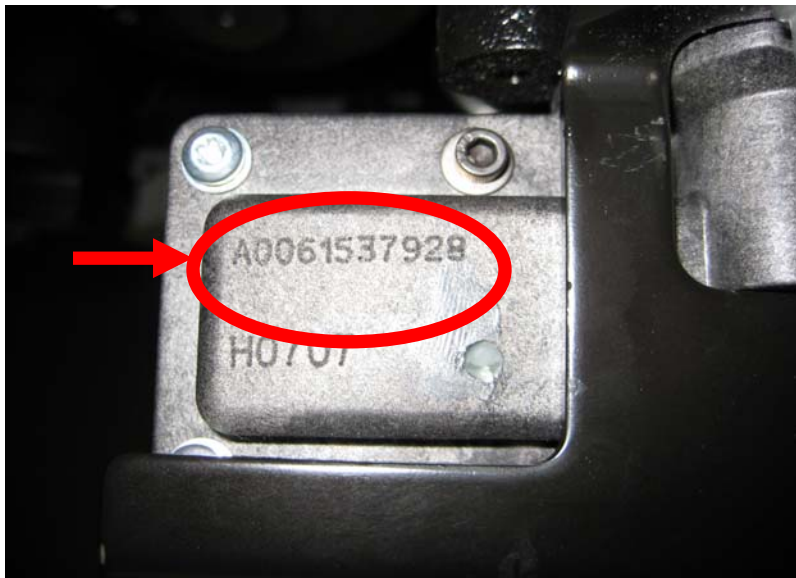
**Figure 1** – EGR Delta Pressure Sensor Part Number Location

2. Check the part number of the sensor currently installed on the engine.  
Reference Figure 1.
  - a. If the part number is **A4701530028**, then no further work is needed, update the door sticker to indicate that 13M2 is complete.
  - b. If the part number is **A0061537928**, then continue with sensor replacement.

3. Replace the sensor with the new one in the service kit. **Reference** 18SP705 found in the kit.
