September 24, 2013

SUBJECT: **GHG14 472906S Turbocharger Compressor Inlet**

**Preliminary**

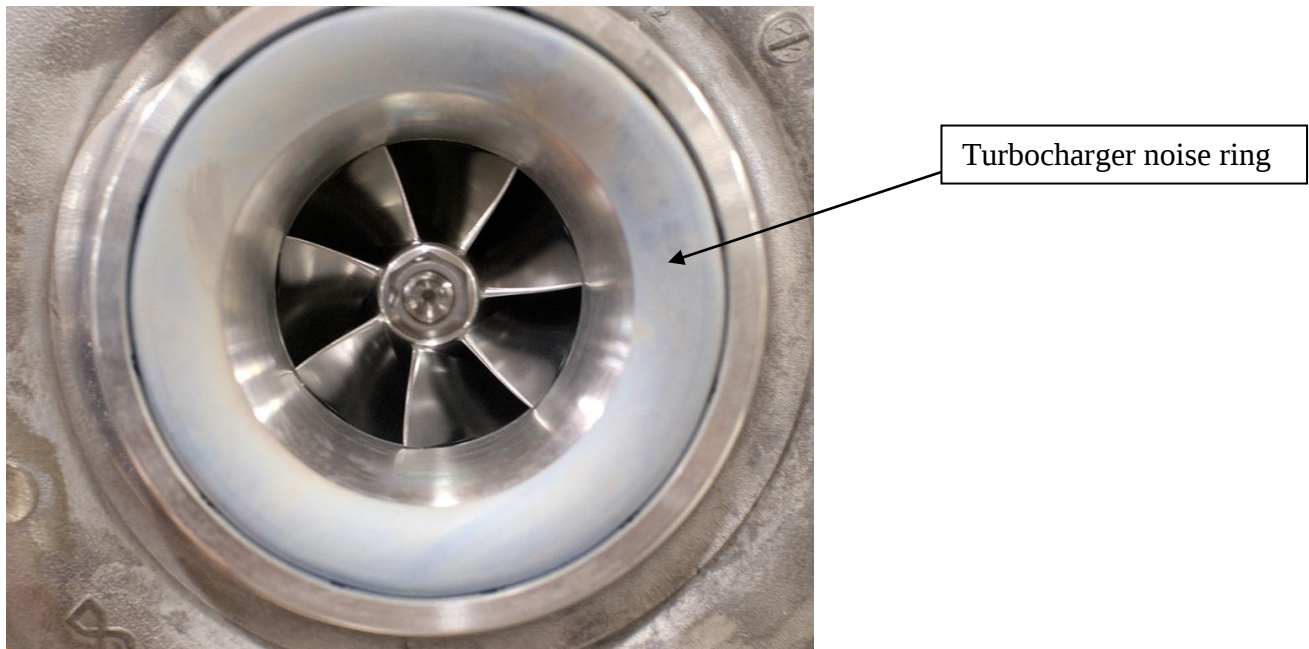
The turbocharger installed on the DD15AT engine model 472906S has a steel ring inserted in the compressor inlet housing to reduce noise generated by air flow into the turbocharger. The ring is loosely pressed into the compressor housing and seats on a counterbore machined in the housing. The insert may appear to be loose when the turbocharger compressor inlet is visually inspected. The ring seats on the counterbore in the compressor housing and presents no performance or service issue.

Figure 1 Turbocharger Compressor Inlet Noise Control Ring

No repair action is required. A claim submitted through the warranty system for replacement of a turbocharger based on a loose steel insert will be denied.
