Date: 01.10.2013

Model: Evora/Elise/Exige
(Fitted With Cruise Control)

Number: 2013/15

Potential causes of cruise control deactivation without intentional driver intervention.

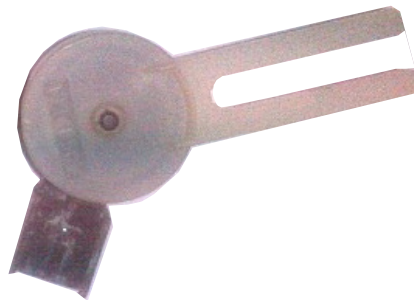
Note: If any of the above codes are generated then the clutch potentiometer should be also inspected to confirm which version of potentiometer is currently fitted to the vehicle. Although the part number has not changed, internal modifications to the latest potentiometer fitted make it less susceptible to the generation of the fault codes displayed above.

Early level clutch potentiometer with either black or translucent coloured arm

If the vehicle is fitted with a potentiometer with either a black or translucent arm, then it is recommended to replace it with the latest level assembly with a solid white arm in the first instance.

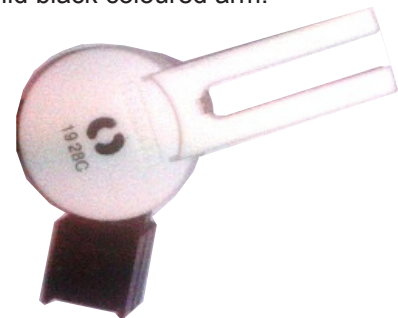
The latest level of potentiometer can be identified by its solid white coloured arm; previous versions have either a translucent white arm and very early versions had a solid black coloured arm.

Latest level clutch potentiometer with solid white coloured arm

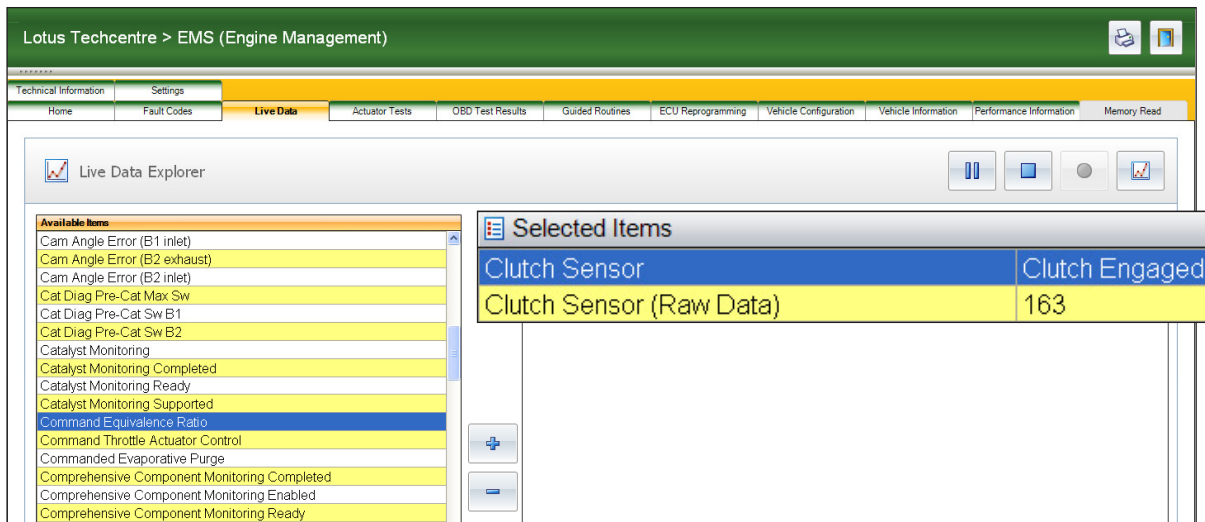
With the clutch pedal released (pedal in fully upwards position) a 'raw' data value* reading of between 100 - 160 bits should be displayed.

If the readings displayed are not within these limits then this indicates that the voltage difference between maximum and minimum clutch positions is not within the acceptable limits and the clutch potentiometer should be renewed to eliminate it as a cause of fault code generation.

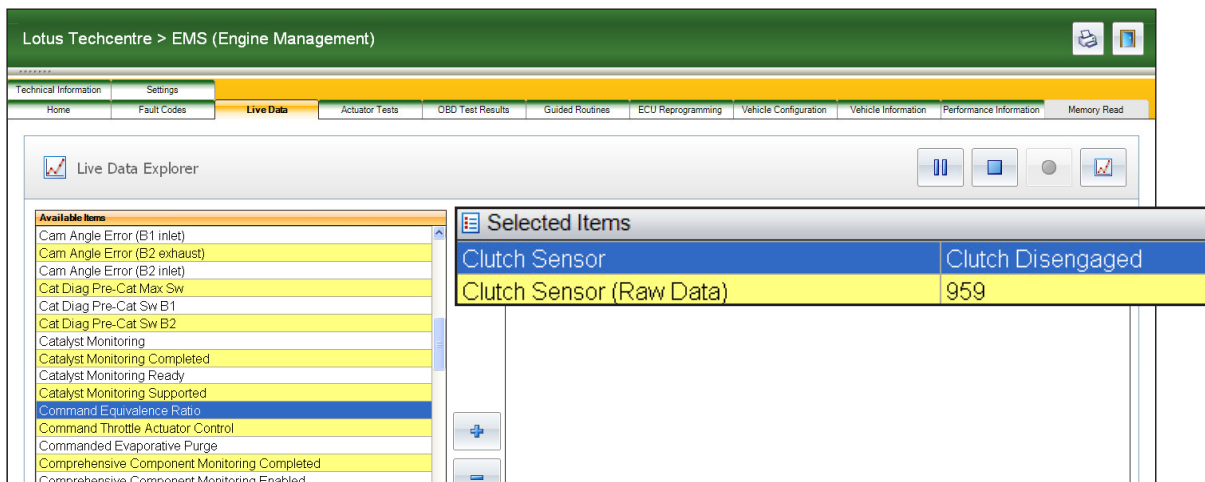
With the clutch pedal depressed (pedal in fully downward position) a 'raw' data value* reading of between 900 - 990 bits should be displayed.
