SI B11 10 12
Engine

January 2013
Technical Service

N20 Engine: Repeated Juddering or Surging While Accelerating

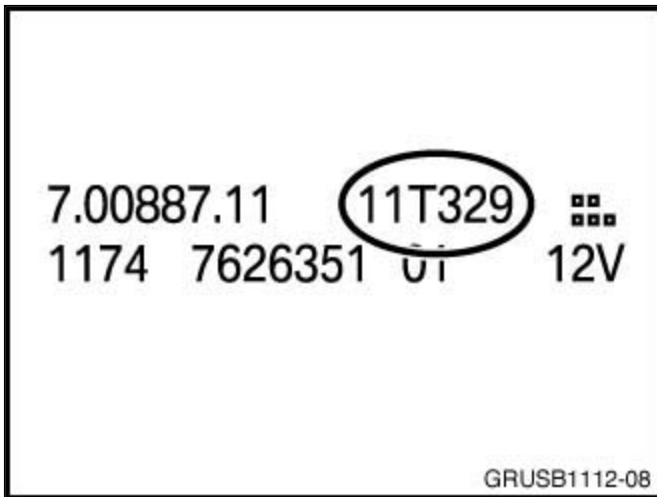
The date code located on the side of the EPDW needs to be 12T158 or greater.

If the date code is 12T157 or lower, the EPDW will need to be replaced.

Do not remove the EPDW.

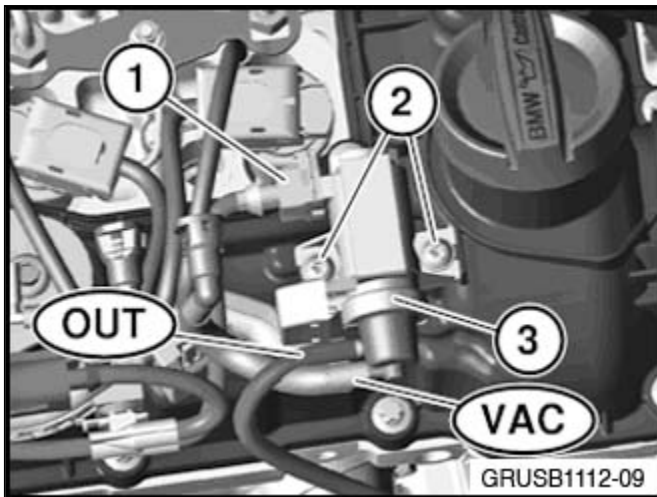
The EPDW (electropneumatic pressure convertor) for the turbocharger wastegate valve is binding internally.

4. Remove the electrical connector (1).
5. Remove the screws (2).
6. Remove vacuum lines marked "OUT" and "VAC."
7. Remove EPDW.
8. Install the new EPDW, connectors and vacuum lines. Install and torque the attaching screws to 3 Nm (2).
