This Service Information bulletin supersedes SI B11 11 12 dated November 2012.

**NEW** Recall Campaign 12V-550:: Replace Hex Bolt with Internal Thread for Deflection Pulley

E70 with M57Y engine

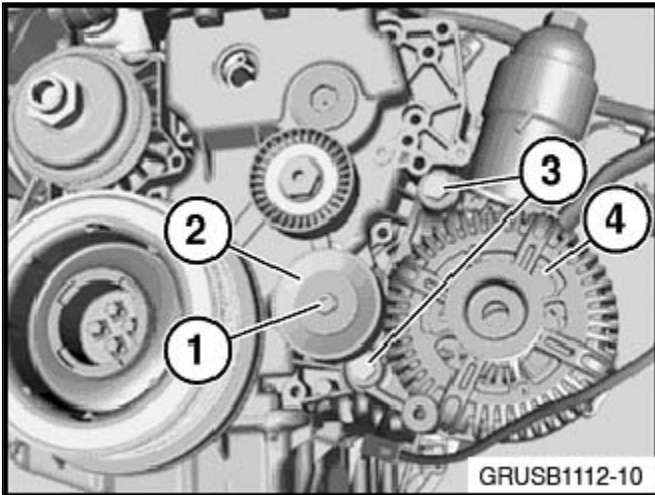
One of the alternator attaching bolts may fail. Subsequently the vehicle may lose power steering assist while driving. If power steering assistance is lost, the vehicle will remain controllable through the mechanical steering system, but with increased steering effort.

3. **NEW** Remove cover (1) from deflection pulley (2) to access the mounting bolt.
