SUBJECT**N63 and S63 Engine: High-pressure Fuel Injector Replacement Procedures****MODEL**

SITUATION

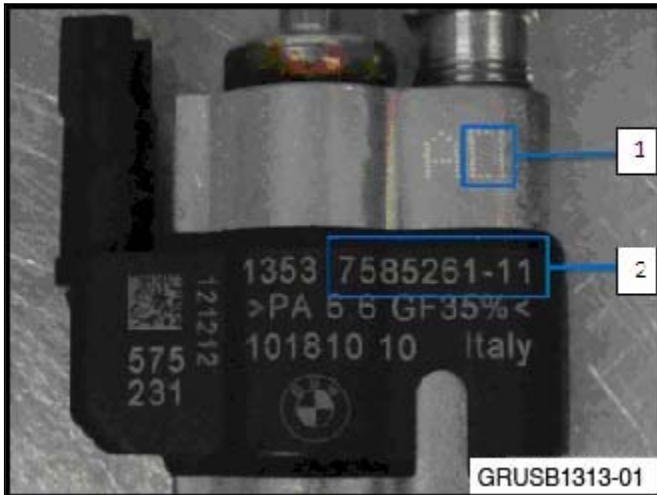
7. The following screen will advise the replacement of all 8 injectors. Use P/N 13 53 8 616 079 when replacing all 8 injectors.
