Anti-trap Is Activated when Raising the Front Side Windows

E89

E93

Vehicles produced from November 2006 to August 2011

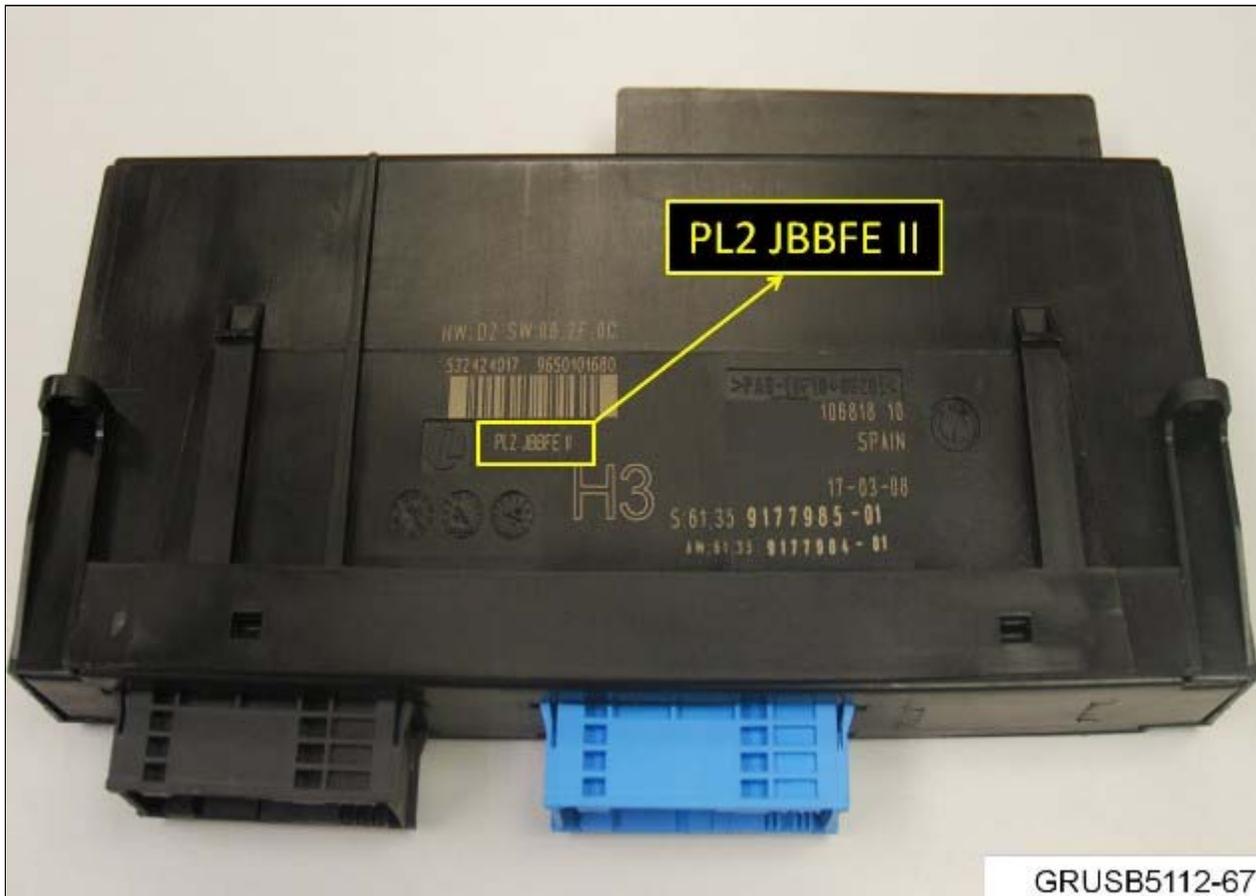
5. To identify the JBE version (1, 2, or 3) installed in the vehicle, you must remove the JBE and visually check the label on the JBE. The picture below shows a JBE 2.

6. **NEW** For vehicles produced up to August 31, 2009 with JBE 1 or 2:
 - a. Install JBE 3 P/N: 61 35 9 264 579 for vehicles equipped with JBE 1
Install JBE 3 P/N: 61 35 9 264 577 for vehicles equipped with JBE 2.
