SUBJECT**Head-Up Display Is Too Dark****MODEL**

The Head-up Display (HUD) is too dark.

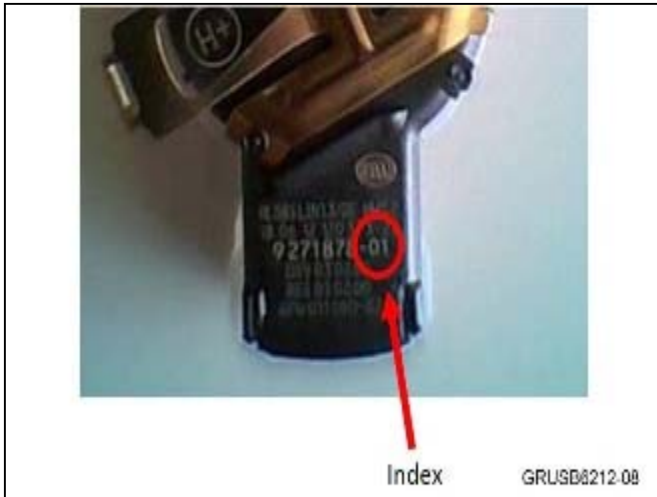
2. Check the Aenderungs Index (AI) on the installed RLSB sensor if there is no relevant fault code stored for this issue.

Note: The improved RLSB sensor has an AI number of 02 or higher.

3. Replace the RLSB sensor if the AI number on the RLSB sensor is 01.
