This Service Information bulletin supersedes SI M17 08 12 dated **October 2012**.

Service Action: Retrofit of the Engine Coolant Temperature Sensor

This Service Action involves R55, R56, R57 and R58 MINI Cooper/Cooper S vehicles with the N16 or N18 engine which were produced from 8/2010 to 3/2012.

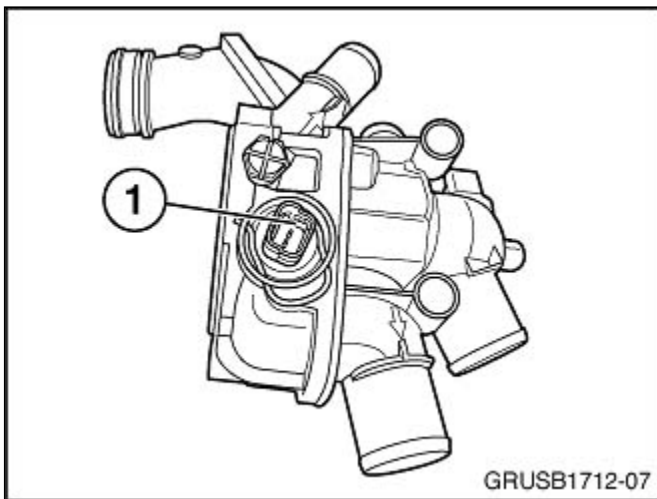
Checking for updated thermostat: The 11 53 7 534 521 thermostat has a replaceable engine temperature sensor (1).
