This Service Information bulletin supersedes SI M17 09 12 **dated November 2012.**

**Service Action: Retrofit of the Engine Coolant Temperature Sensor**

R55

All with **automatic transmission** and either the N16 or N18 engine

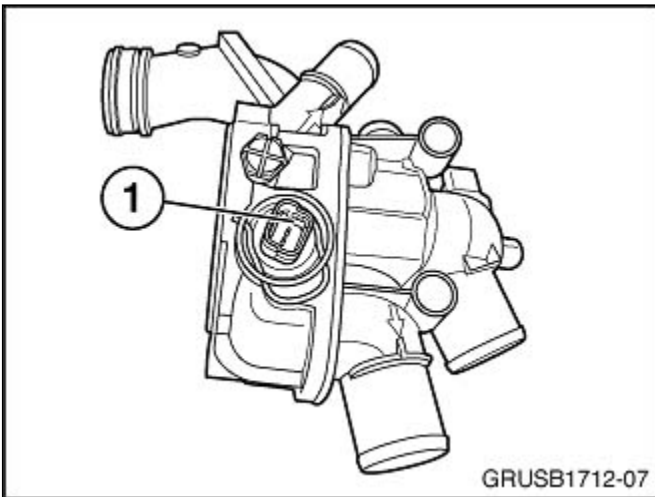
Checking for updated thermostat: The 11 53 7 534 521 thermostat has a replaceable engine temperature sensor (1).

- Replace the engine wiring harness with the 11 53 7 534 521 thermostat.
- Do not install the remote engine temperature sensor. Claim the labor operation “Check for 11 53 7 534 521 thermostat installation” in the Warranty Information section of this bulletin.
- Affix the Service Action label to the B-pillar.

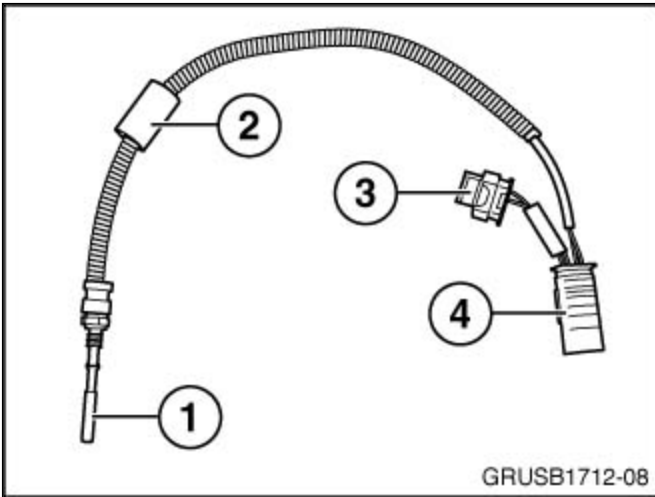
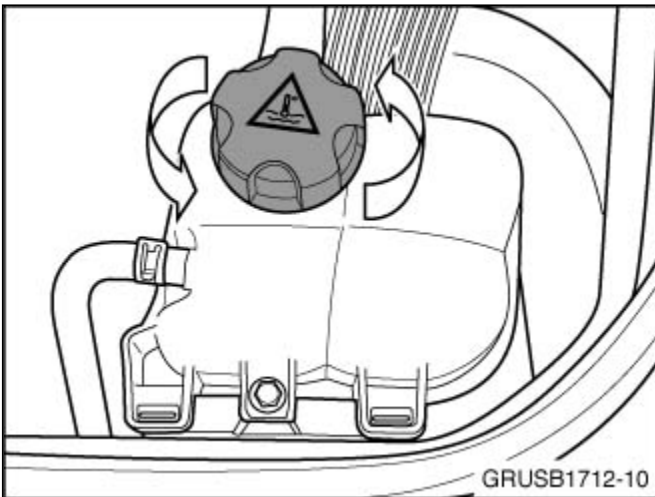
The improved sensor (P/N 13 62 8 603 908) includes the temperature probe (1) and insulating sleeve (2), a two-pin female connector (3) for the map thermostat, and a four-pin connector (4) for the engine harness.

Relieve the coolant pressure by removing the reservoir cap, and then re-tighten.
