This Service Information bulletin supersedes SI M17 10 12 **dated October 2012.**

**Engine Cranks, No Start and/or Engine Coolant Temperature Faults**

All with the N18 engine

Produced from 3/2012 to 8/2012

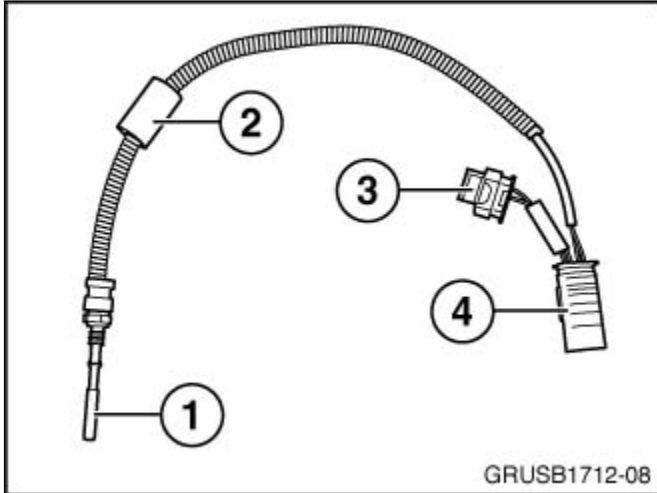
The improved sensor (P/N 13 62 8 603 908) includes the temperature probe (1) and insulating sleeve (2), a two-pin female connector (3) for the map thermostat, and a four-pin connector (4) for the engine harness.
