**Service Action: Program Control Units (OBD Communication)**

F10 (ActiveHybrid 5) produced to 8/1/2012

F30 (ActiveHybrid 3) produced to 8/10/2012

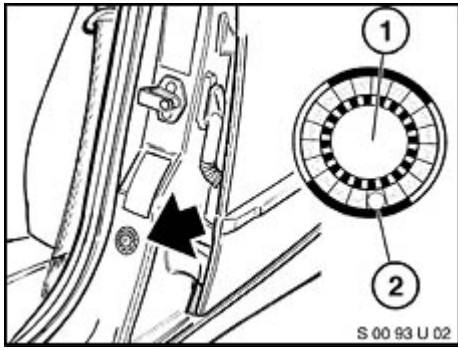
This Service Action has been assigned code number **624**. After the vehicle has been checked and/or corrected, obtain a label (SD 92-417) and:

- A. Emboss your BMW center warranty number in the middle of the label (1);
- B. Punch out code number **624** (2), printed on the label; and
- C. Affix the label to the **B**-pillar as shown.

If the vehicle already has a label from a previous Service Action/Recall Campaign, affix the new label next to the old one. Do not affix one label on top of another one, because a number from an underlying label could appear in the punched-out hole of the new label.
