SI B51 15 11
Body Equipment

Headlight Washer Nozzle Cover Sticks Out

NEW E92

NEW E93

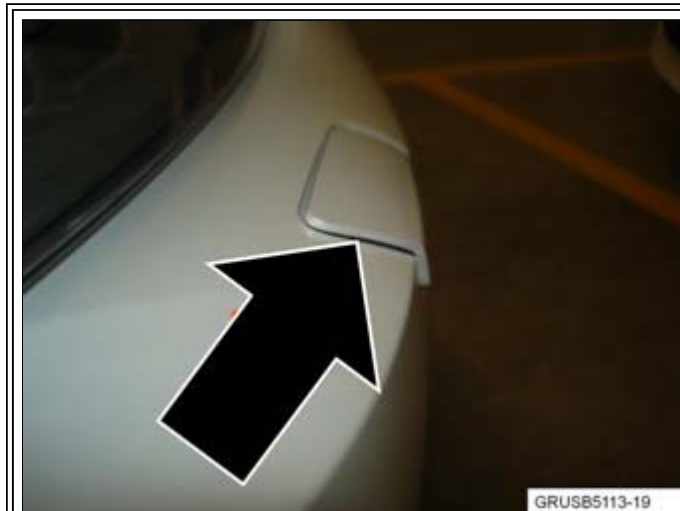
The left and/or right headlight washer nozzle cover tilts in the bumper cut-out.

The customer may state the headlight nozzles are not flush with the front bumper, as shown. In this case, both left and right nozzle covers must be replaced.
Refer to ISTA Repair Instruction 51 11 ... "Removing and installing/replacing cover for headlight washer with special tool."
