SI B54 01 13
Special Roofs

Convertible Top Makes Thumping Noise During Operation

E88

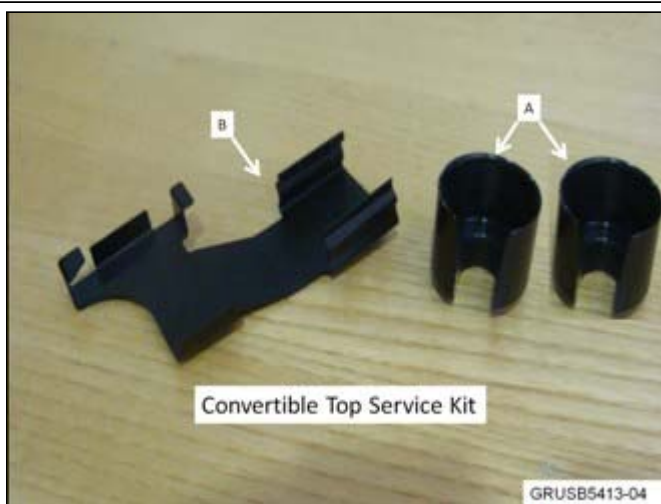
2. This picture shows the parts contained in the service kit for the convertible top brace. It contains 2 spacer sleeves (A) and 1 spring plate (B).

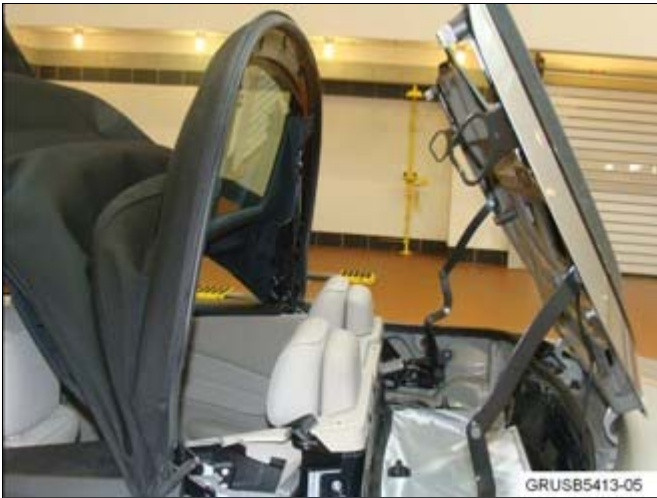
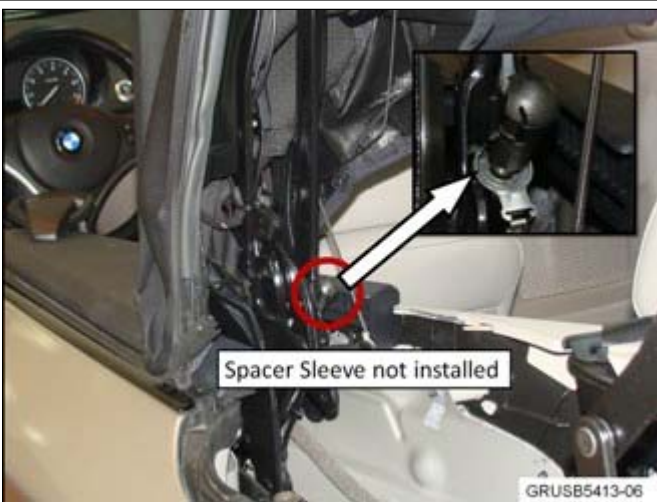
6. Locate the hydraulic cylinders on both the left and right. The left side is shown in the picture.
7. This picture shows the top of the tension rod for the convertible top hydraulic cylinder without the spacer sleeve installed.

3. Position the top in the service position, as shown.
4. Switch off the ignition.
5. Using an appropriate tool, prop both the convertible top and the

storage compartment lid open.

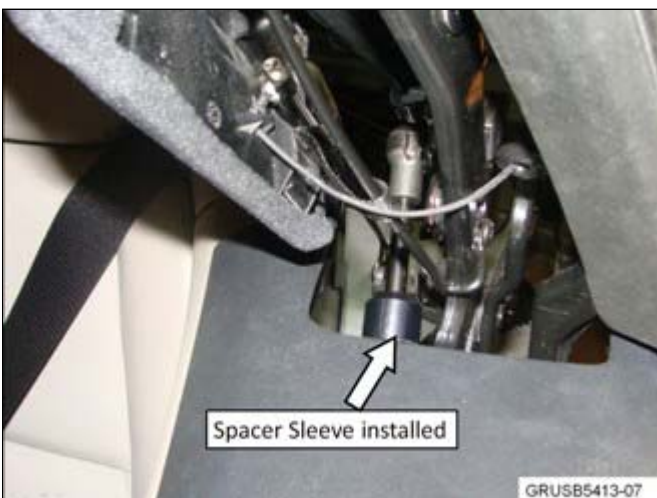
11. The left side is shown in this picture.

8. Using your hand manually, move the rear portion of the convertible top with the glass to expose the tension rod.
9. Install the spacer sleeve over the top of the hydraulic cylinder, as shown.
10. Install one spacer sleeve on each side.

Note: When installing the spacer sleeve, the notch must be facing downward.

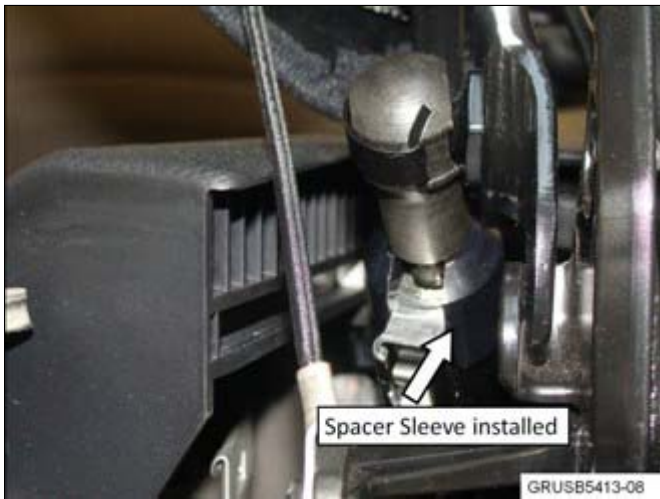
12. This picture shows the sleeve installed on the right-side hydraulic cylinder.
13. Press down on the spacer sleeve to ensure it is properly installed, as shown.

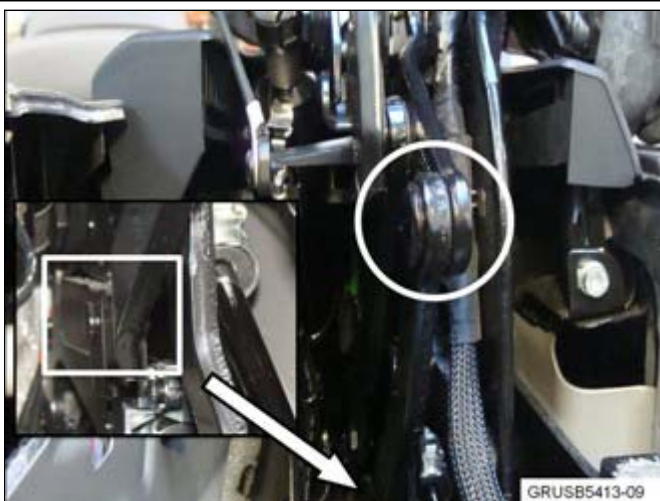
14. On the right side of the vehicle, locate the convertible top fabric holder guide arm, indicated by the circle.
15. Follow the guide arm down to its lower section. This area is indicated by the square.

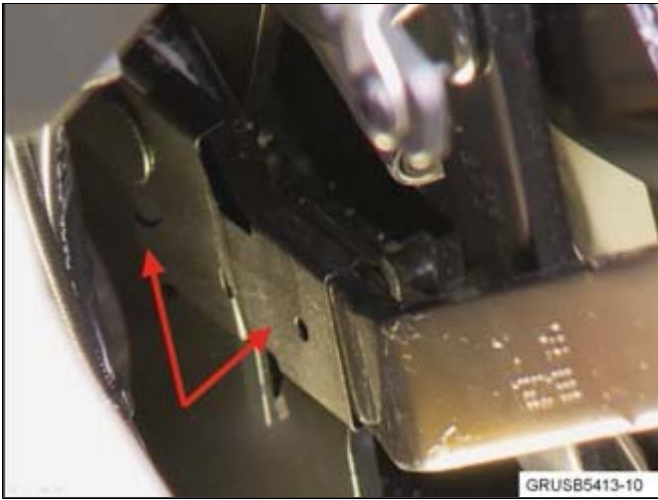
The rear window on the convertible top contacts the top hoop, and makes a knocking noise when opening or closing the convertible top.

The tolerance between the convertible top rear window and the convertible top cover hoop is insufficient.

16. Attach the spring plate to the fabric holder guide arm on the right side of the vehicle, as shown.
17. This will correct the shift point of the Hall sensor, thus limiting the travel of the convertible top and preventing the rear glass from contacting the rear hoop of the top.
18. Retest the operation of the

convertible top by performing a complete open and close operation.

Note: Operating the top will ensure the spacer sleeves are properly snapped in over the hydraulic cylinder.
