February 2013
Technical Service

Noise from the Door Mirror when Opening the Front Door

F30

Produced from October 18, 2011 with option code SA760 (high-gloss shadow line)

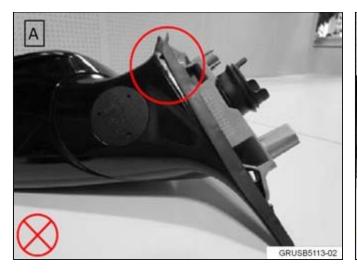
A grating noise may occur in the area of the mirror triangle when the door is opened or closed.

The door mirror triangle fitment to the mirror recessed cover

- 1. Confirm the noise is coming from the mirror triangle seal by opening and closing the front door several times.
- 2. Refer to ISTA Repair Instruction 51 16 000, "Remove and refit/replace door mirror on left or right front door."
- 3. The triangle sealing lip is not fully formed over the mirror housing, as shown in picture A.
- 4. Re-fit the sealing lip as shown in picture B.
- 5. Reinstall the removed parts in the reverse order of their removal.
- 6. Open and close the door several times to confirm the noise has been eliminated.
