**SUBJECT****Noise from Front Windshield****MODEL**

F30

Produced from October 16, 2011 to November 22, 2012

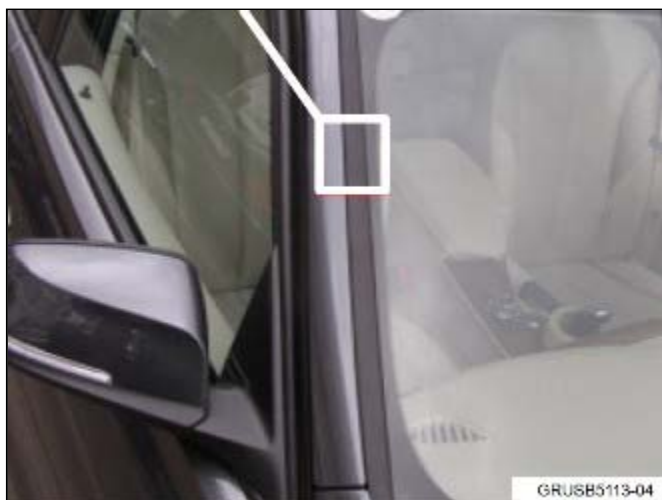
When driving at varying road speeds, a wind or whistling noise may be heard coming from the windshield at the A-pillars.

1. Confirm the noise is coming from the front windshield, near the left and/or right A-pillar area.

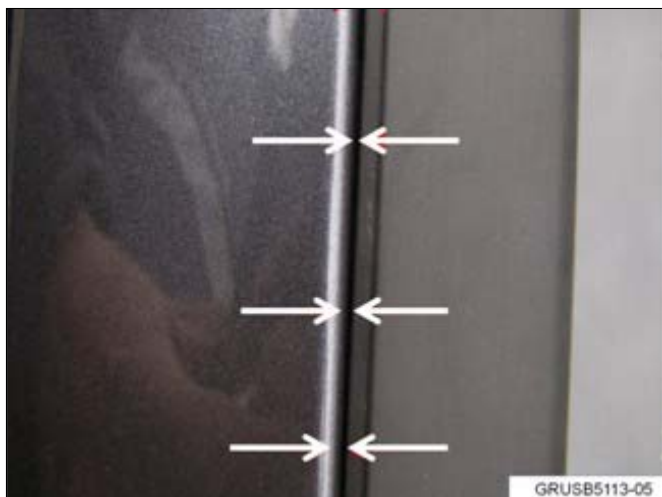
The gap between the drip molding and the A-pillar is excessive or uneven.

2. If a gap is seen between the affected A-pillar and the drip molding, the molding must be replaced. Refer to ISTA Repair Instruction 51 31 030, "Remove and install or replace the left or right side gutter strip." Install the replacement drip molding with the new blue colored clips listed below.
