February 2013
Technical Service

Grating/Grinding Noise from the Center Console

F06

Produced from July 2011 to April 2012

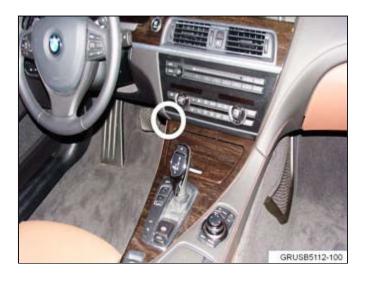
A grating noise can be heard coming from the left front side of the front console trim panel, where it meets the instrument panel, especially when driving on rough roads.

Insufficient gap clearance between the console trim and the instrument panel.

Reproduce the grating noise by pressing on the left side securing clip of the center console trim, and then proceed to the next step.
