**SUBJECT****Front Seat Headrest Height Changes****MODEL**

F30

Produced from October 31, 2011

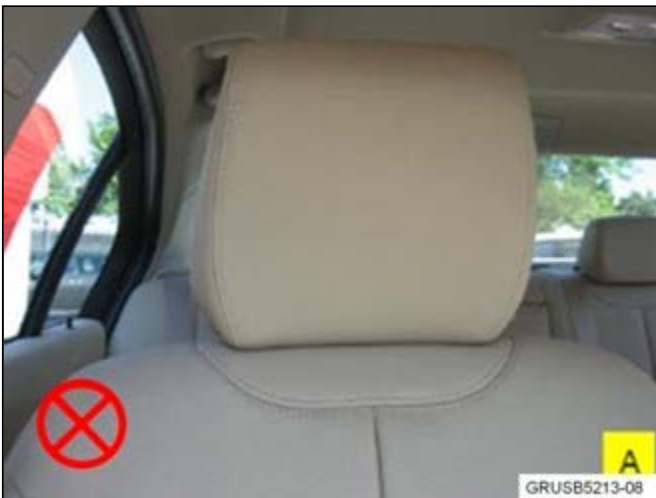
1. The headrest in picture A is lowered all the way down at the factory. This simplifies the seat installation and reduces damage on the production line. The headrest operation should be checked during PDI, and, once raised, the headrest will no longer lower down to the “installation” height. This is normal headrest operation and no repairs are needed. **No new vehicle should be delivered to the customer with the front headrests in the “installation” position.**

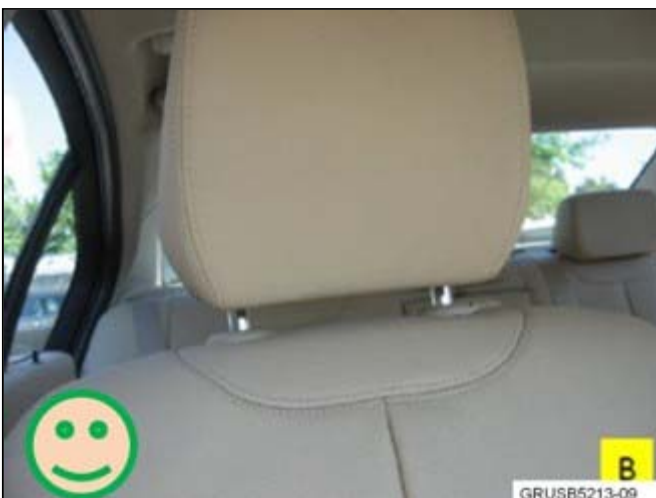
2. The headrest in picture B is in the correct lowered height position.
