After FEM Replacement, ISTA/P Unable to Read Vehicle Order

F30

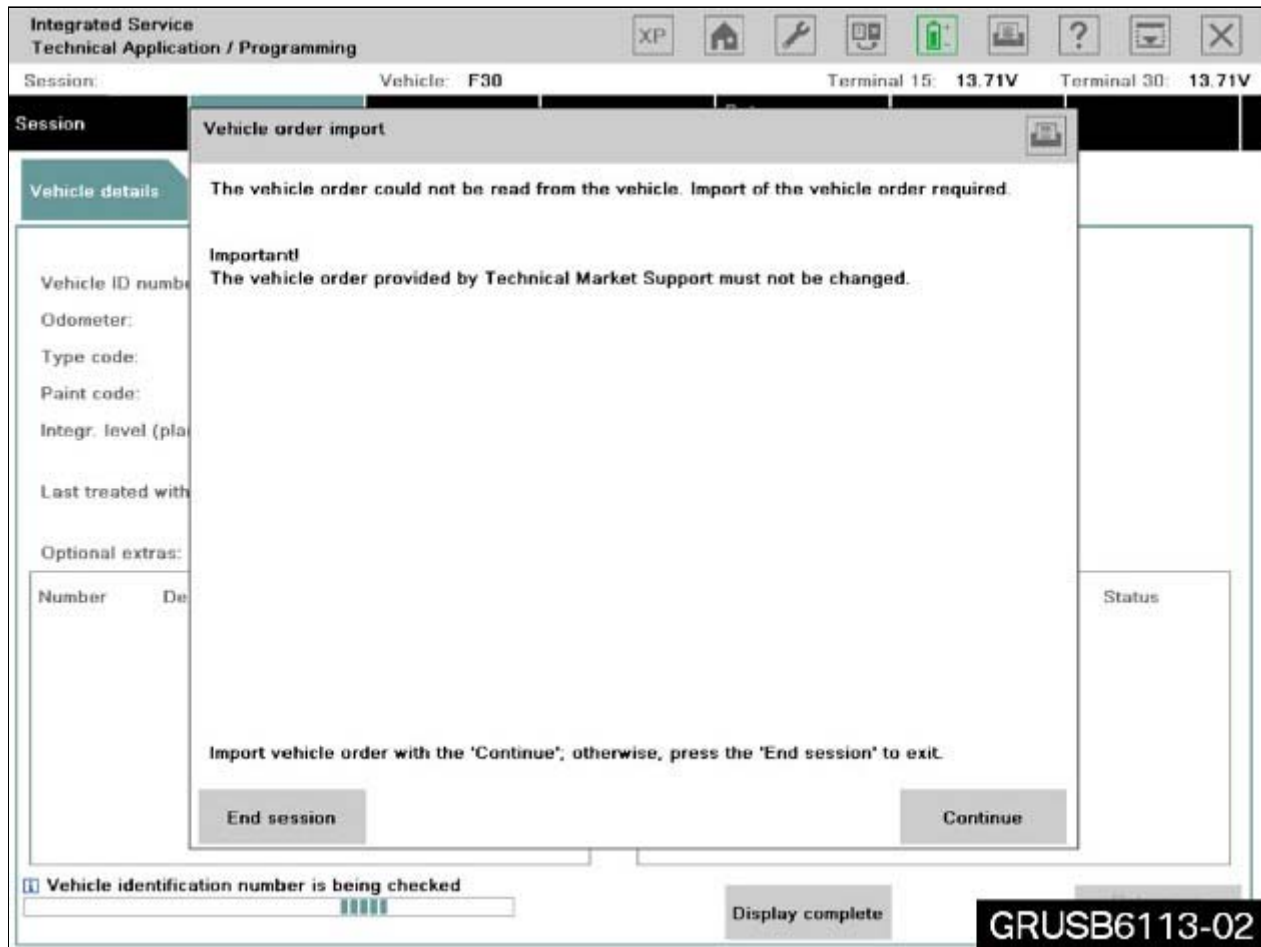
After the FEM (Front Electronic Module) is replaced, ISTA/P states “The vehicle order could not be read from the vehicle. Import of the vehicle order required.”

The replacement FEM does not contain the vehicle-specific data, including the Vehicle Order (VO). The proper ISTA/P parts replacement procedure was not performed.

1. If the original FEM is available and communicating, connect it to the vehicle and follow the ISTA/P part replacement procedure as outlined in TIS video 07 15 12. This can be accessed via the following path: Service Reference / Service Roundtable / General Search / Main Group 7.

2. If the original FEM is no longer available or not communicating, submit a PuMA case and request a vehicle order for the vehicle.
3. Download and import the vehicle order into ISTA/P, and finish the programming as displayed by the measures plan.
