**SUBJECT****Moisture in LED Headlight****MODEL**

F01

F02

F04

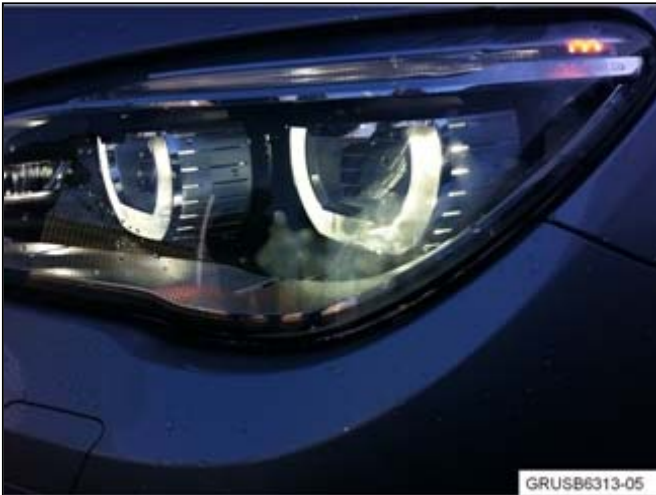
Condensation or fog forms inside the LED headlight lens cover

Water enters the headlight from the headlight ventilation filter.

Do not replace the headlight. Follow the modification procedure below to remove the ventilation filter:
