Noise from Steering Column when Turning or Adjusting Height

R60

Produced from 8/2010

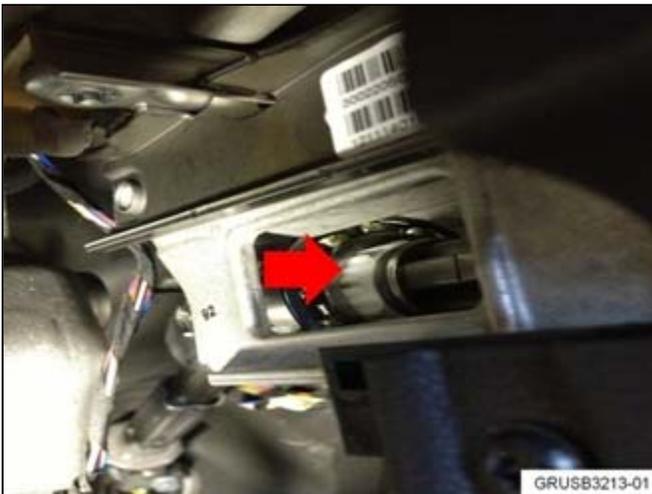
A squeaking noise is heard from the area around the steering column when turning or adjusting its height.

Material contact between the upper steering column bearing inner race and the plastic sleeve

Lubricate the plastic sleeve with lubricant (P/N 83 23 2 327 735). Make sure that when spraying, the steering column is turned at least 360 degrees, and the plastic sleeve is coated with the lubricant at the transition to the inner race of the bearing. **No adhesive lubricant should be sprayed into the grooved ball bearing.**
